FINAL REPORT

**UPDATE OF
PAVEMENT MANAGEMENT PROGRAM
(Citywide)**

2023-2026

City of Sierra Madre, CA

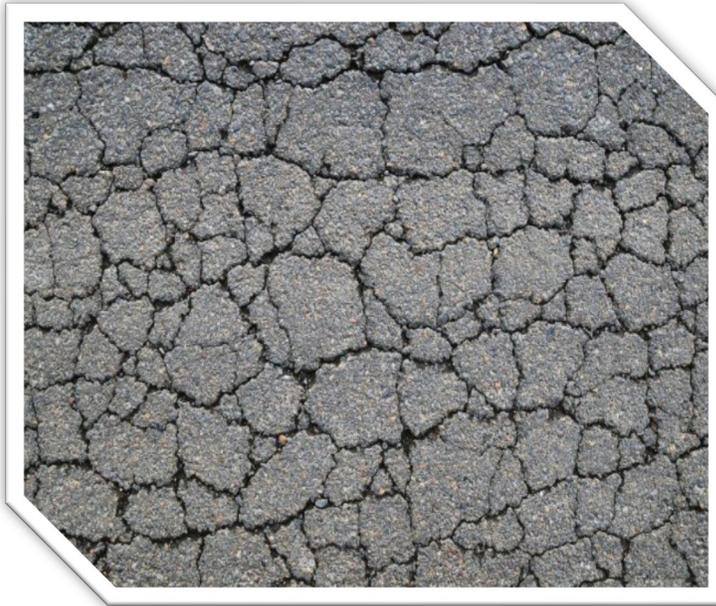
1. Alligator Cracking

Cracks that form a chicken wire or alligator scale like pattern.

Low Severity: Thin parallel longitudinal cracks that may come together at certain points, but full alligator pattern is not present yet.

Typical Recommendation: Low severity, R&R – Patching, crack sealing; high severity R&R-overlay

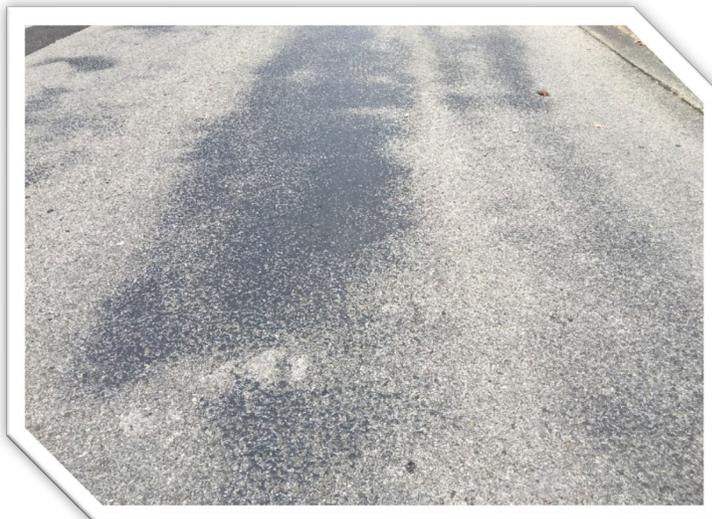
2. Bleeding

Bleeding occurs when incorrectly mixed asphalt is applied and in hot weather the asphalt or tar rises to the surface.

Severity is determined by the amount of asphalt/tar present.

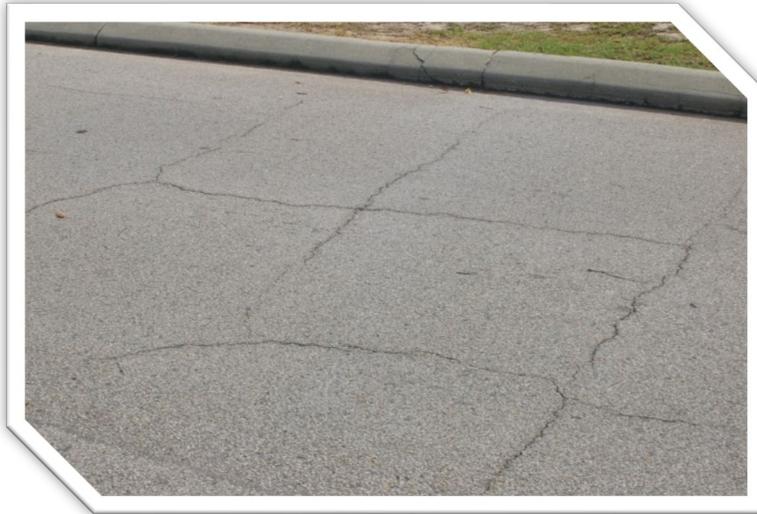
3. Block Cracking

Longitudinal and transverse cracks that intersect to form smaller than 10x10 ft blocks. Creates uniform blocks with straight edges.

Low Severity: Cracking is less than 3/8 inches.

Typical Recommendation: Low severity, crack sealing; high severity, R&R-overlay

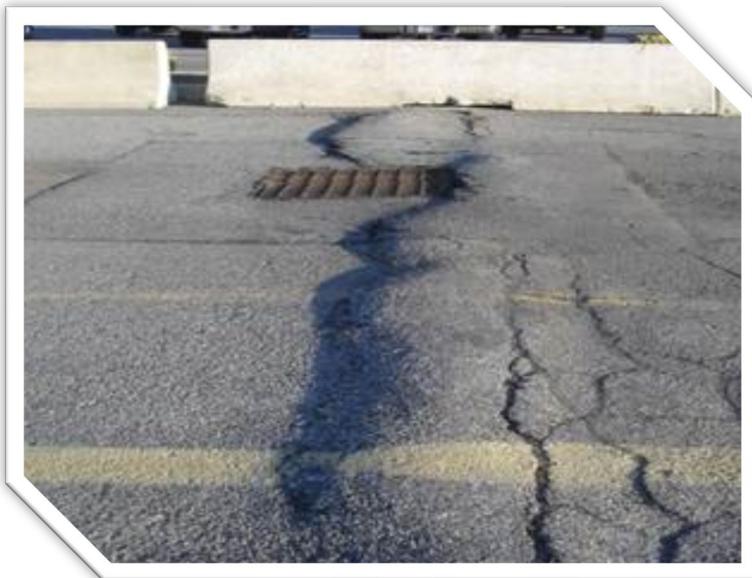
4. Bumps and Sags

Small, localized, and linear upward or downward displacements of pavement, which can be caused by a variety of factors.

Severity is determined by the extent to which ride quality is diminished.

Typical Recommendation: R&R - Patching

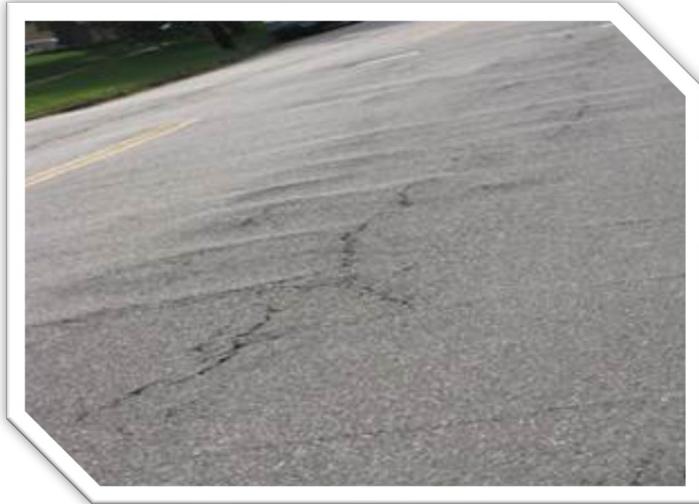
5. Corrugation

Closely spaced Bumps and or Sags that form a washboard effect in the pavement.

Severity is determined by the extent to which ride quality is diminished.

Typical Recommendation: Low severity, R&R – Patching; high severity, R&R-overlay

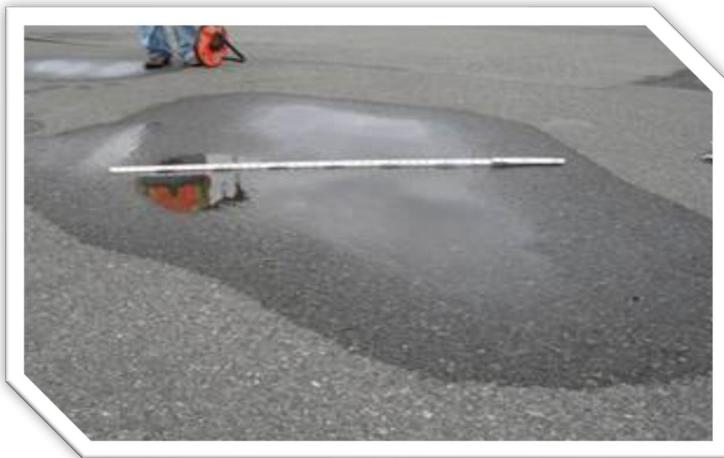
6. Depression

Localized area of pavement with a lower elevation than the surrounding pavement.

Low Severity: depth of ½ to 1 inch.

Typical Recommendation: R&R - Patching

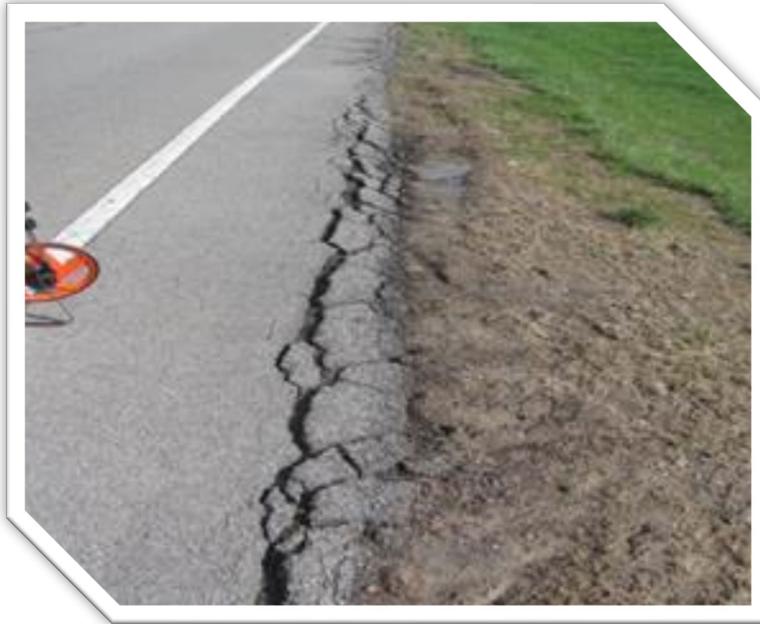
7. Edge Cracking

Cracks that are parallel to the edge of the pavement that may cause a break up of pavement.

Low Severity: Low or Medium cracking with no breakup.

Typical Recommendation: R&R - Patching

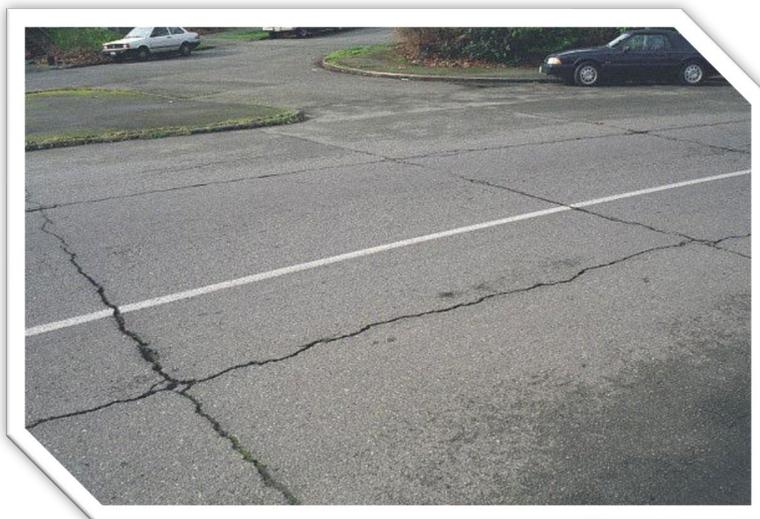
8. Joint Reflective Cracking

Cracking that is reflected through AC pavement when it is overlaid on top of PCC pavement.

Low Severity: Cracking is less than 3/8 inches.

Typical Recommendation: R&R - Overlay

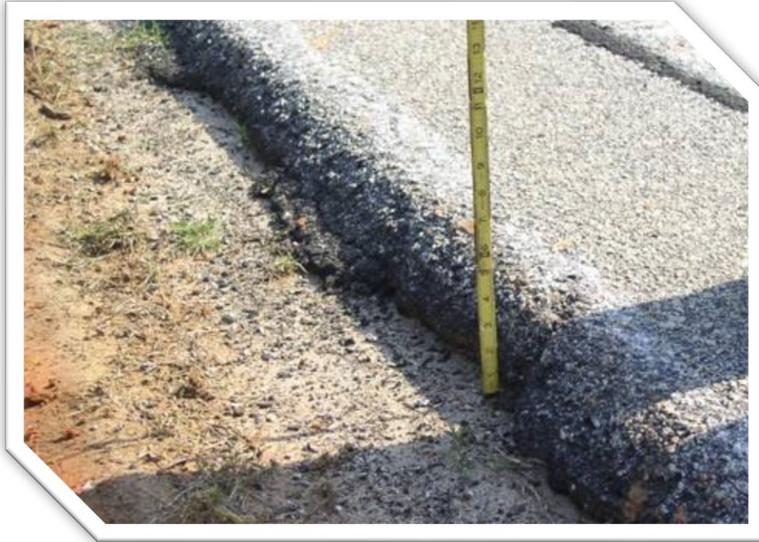
9. Lane / Shoulder Drop-off

Elevation change between pavement and shoulder.

Low Severity: Difference in elevation is between 1 and 2 inches.

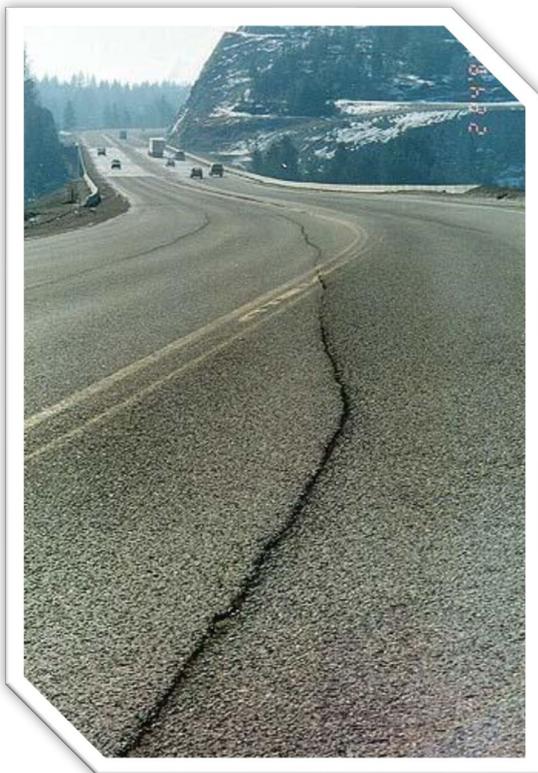
10. Linear & Transverse Cracking

Cracks that are generally either parallel or perpendicular to traffic.

Low Severity: Cracking is less than 3/8 inches.

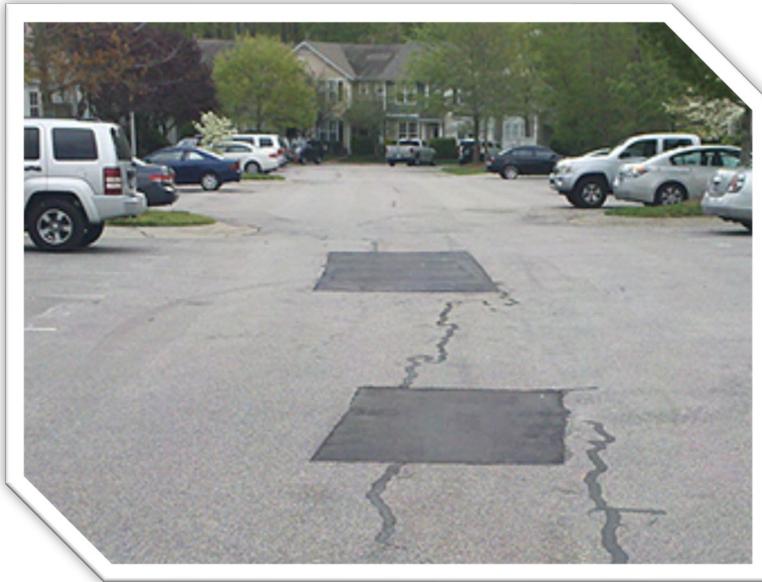
11. Patching

Area of pavement that has been replaced.

Severity is determined by the quality of the patch and the extent to which ride quality is diminished.

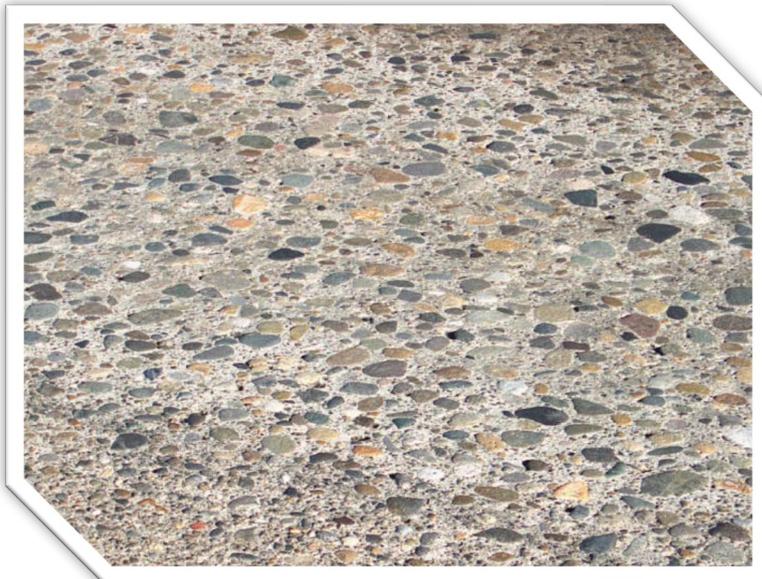
12. Polished Aggregate

Distress where traffic smooths the pavement surface so friction is diminished and cars can slide.

There are no Severity Levels for this distress.

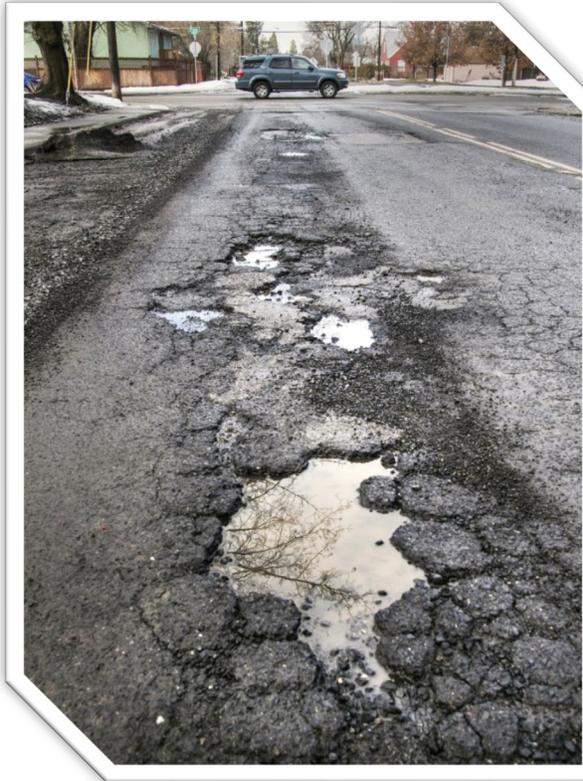
13. Pothole

Severity Measured using the following Matrix.

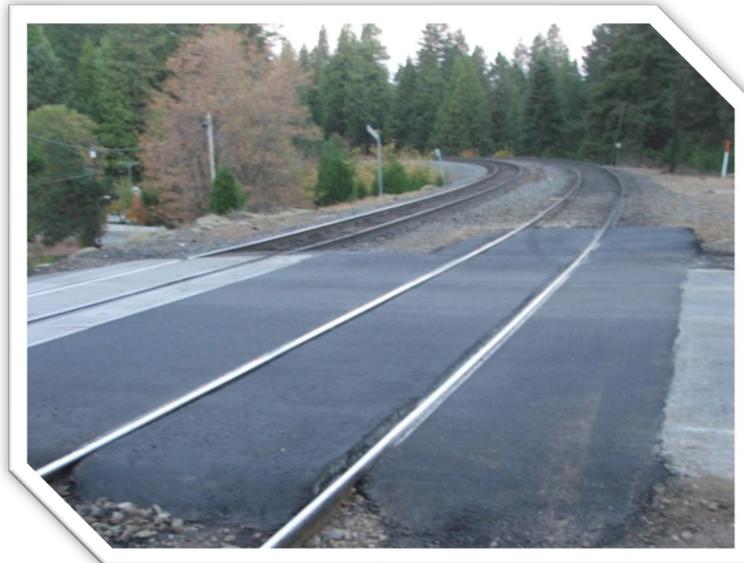
14. RR Crossing

Pavement distresses caused by railroad crossings.

Severity is determined by the extent to which ride quality is diminished.

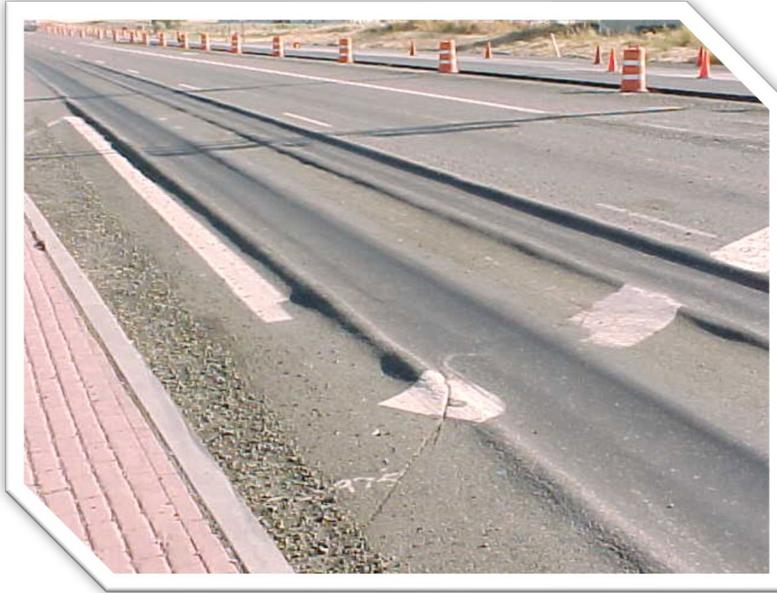
15. Rutting

Linear depressions along wheel paths caused by traffic.

Low Severity: Depth is $\frac{1}{4}$ to $\frac{1}{2}$ inches.

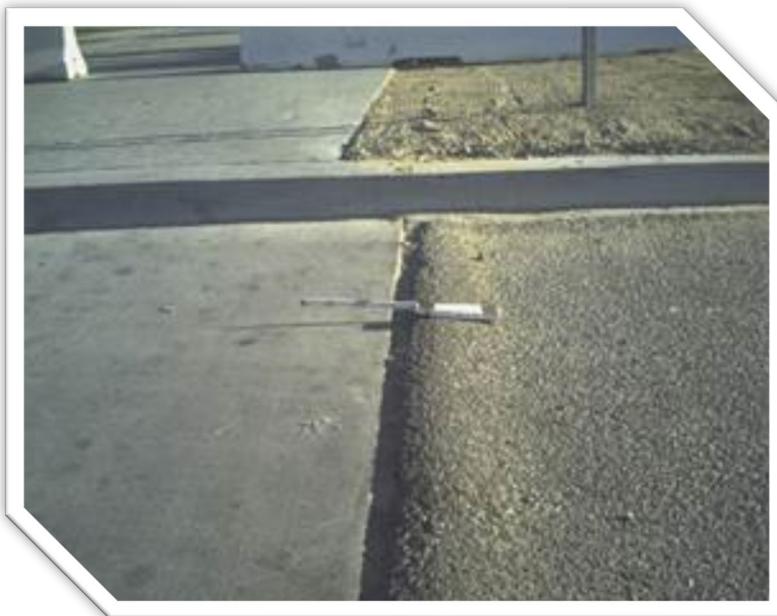
16. Shoving

Displacement of pavement creating a “wave” over a more solid surface.

Severity is determined by the extent to which ride quality is diminished.

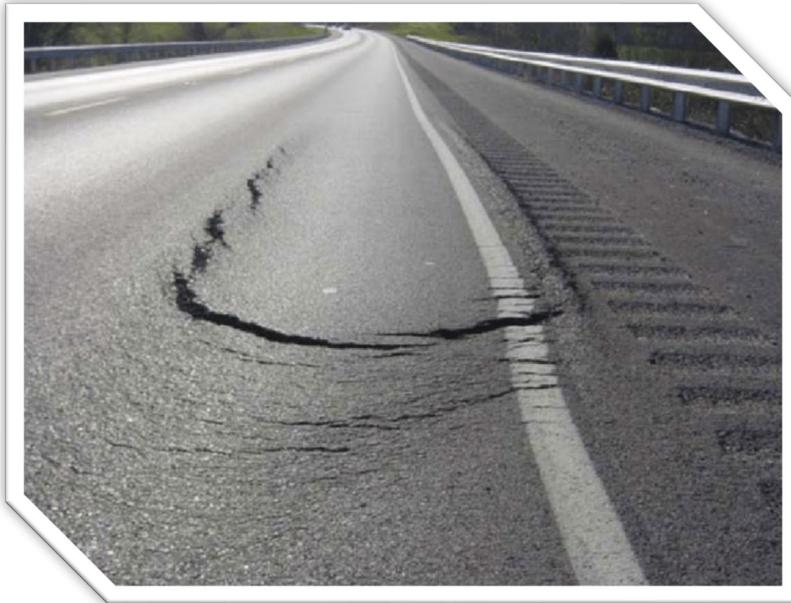
17. Slippage Cracking

Half-moon shaped cracks where wheels cause pavement to slide.

Low Severity: Average crack width is less than 3/8 inch.

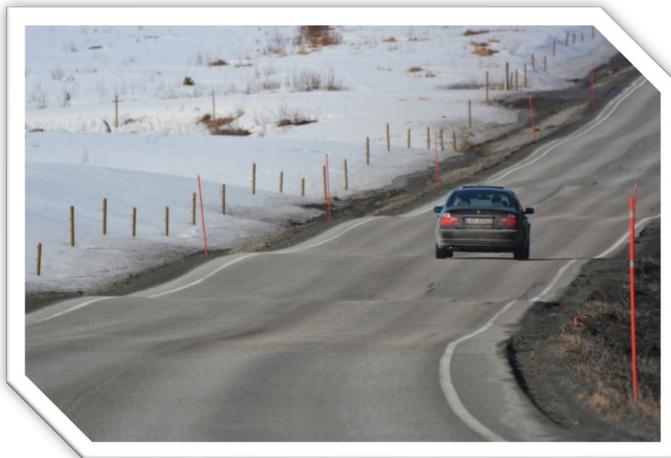
18. Swell

Upward Bulges creating “wave-like” patterns.

Severity is determined by the extent to which ride quality is diminished.

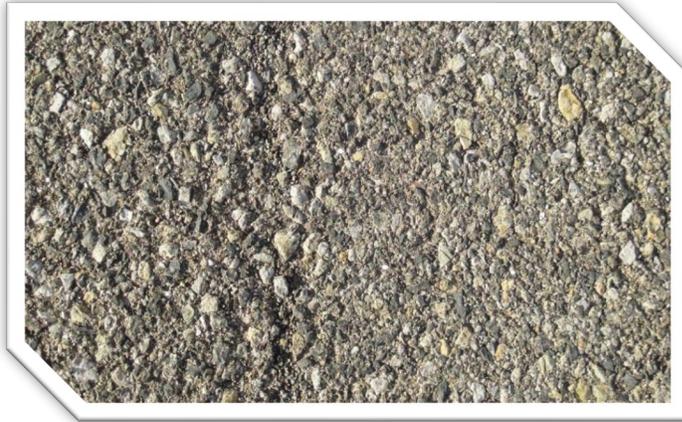
19. Weathering

The wearing away of the asphalt binder.

Low Severity: Aggregate is starting to be exposed.

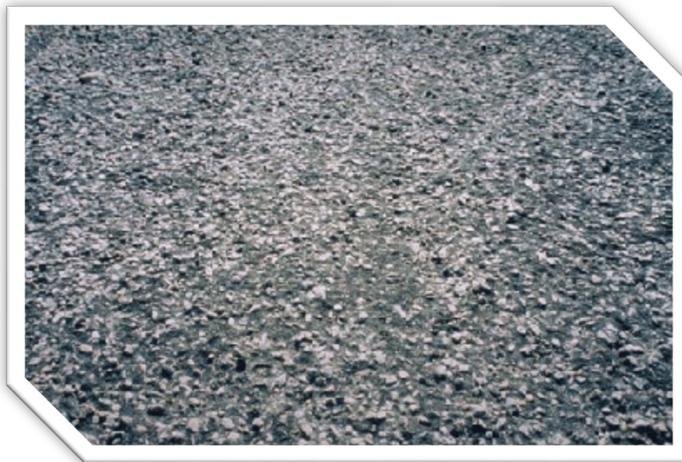
20. Raveling

The further weathering of asphalt so that coarse aggregate is separating out of pavement.

Medium Severity: Considerable loss of aggregate.

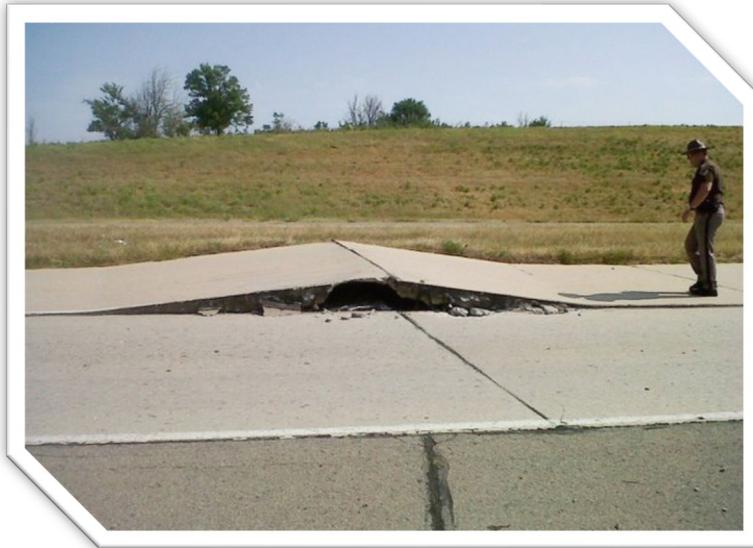
1. Blowup

Buckling at cracks or joints where there is not enough room for slab expansion.

Severity is determined by the extent to which ride quality is diminished.

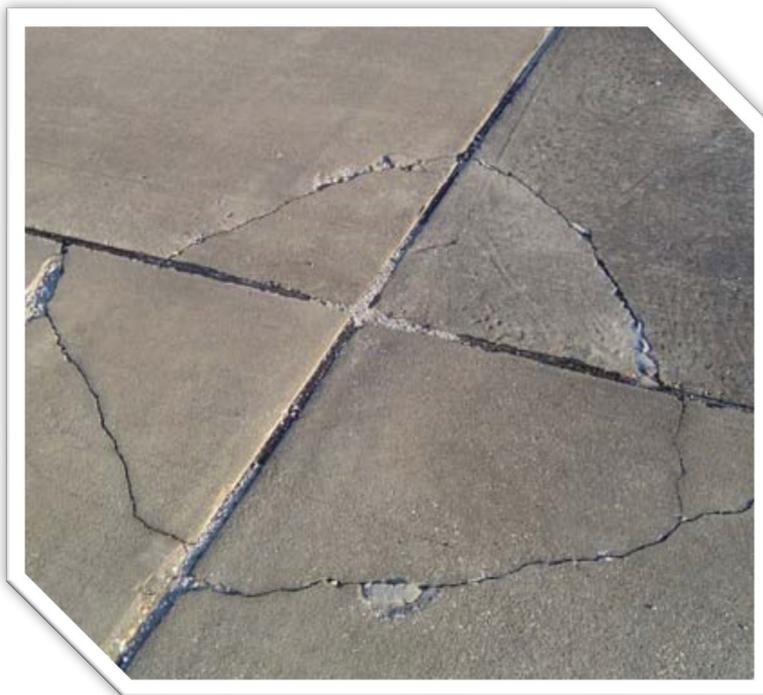
2. Corner Break

Crack close to corner of slab that creates a corner piece.

Low Severity: Crack is less than ½ inches wide.

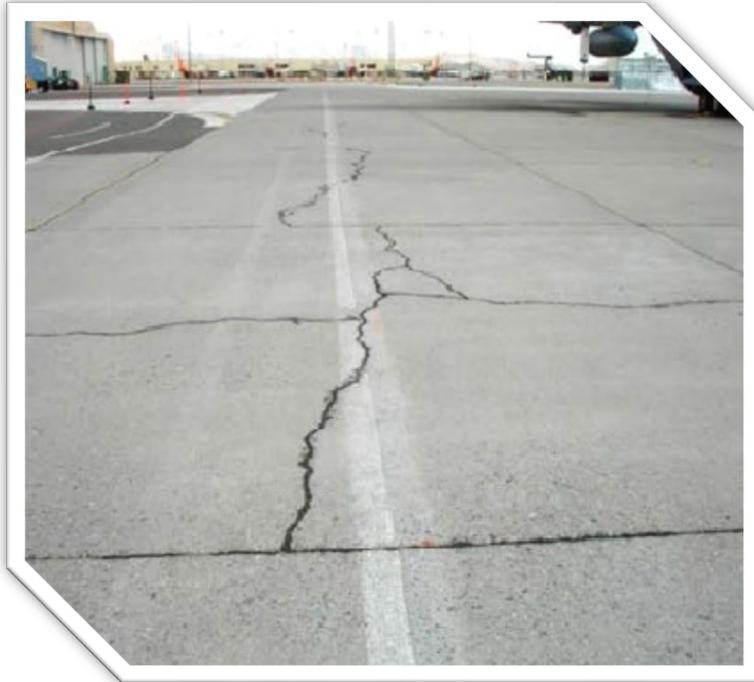
3. Divided Slab

Slab that is broken up into four or more pieces by cracks.

Severity is determined by the following matrix.

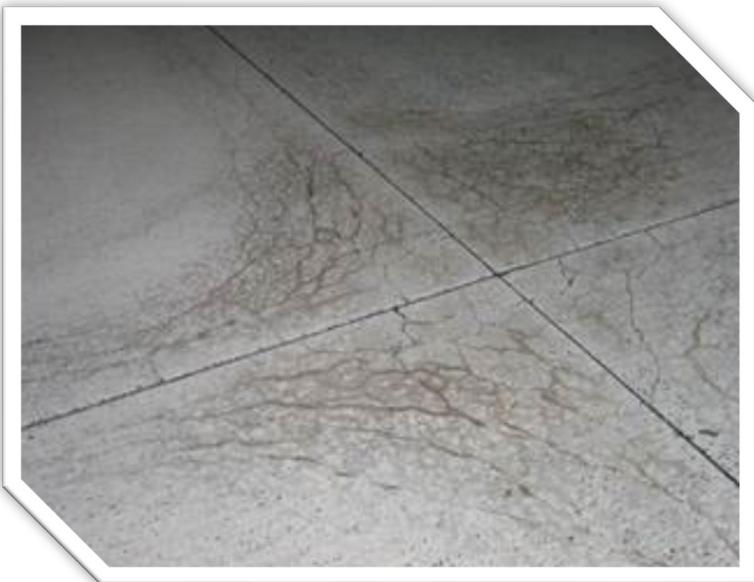
4. Durability Cracking

Pattern of cracks parallel to joints caused by freeze-thaw expansion of large aggregate.

Low Severity: Durability cracking covers less than 15 percent of slab.

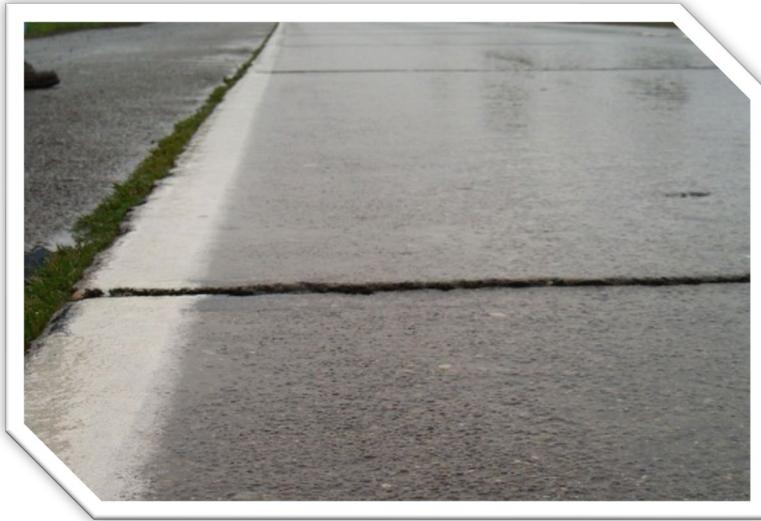
5. Faulting

Elevation Difference between slabs.

Low Severity: Elevation difference is between 1/8 and 3/8 inch.

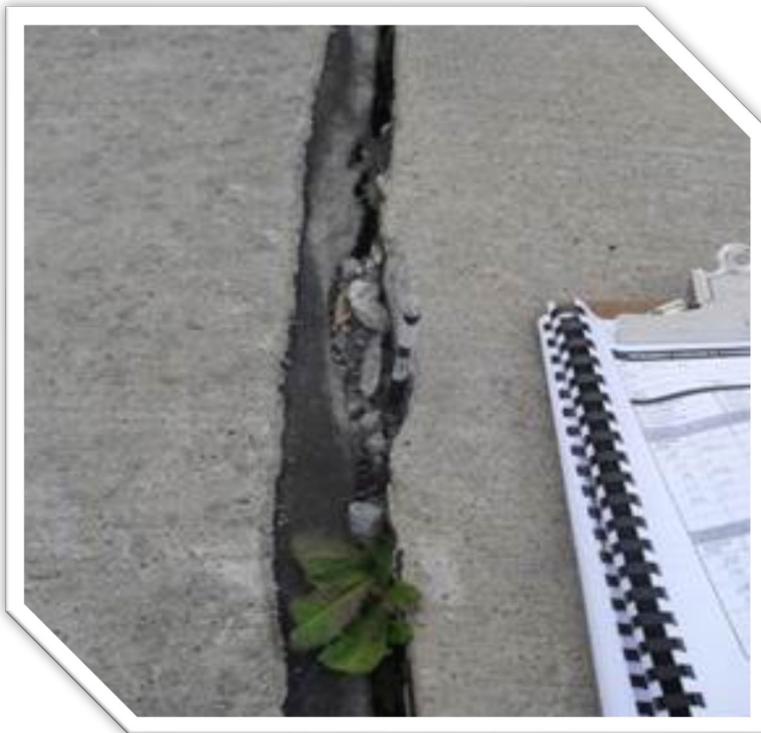
6. Joint Seal Damage

Damage to sealant between joints that allows soil, rock, or water infiltration.

Low Severity: Joint sealant has only minor damage.

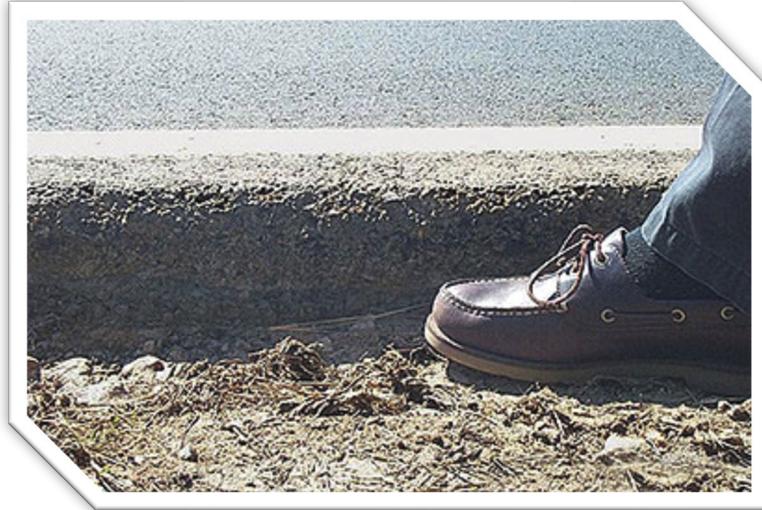
7. Lane / Shoulder Drop-Off

The Elevation difference between pavement and shoulder.

Low Severity: Elevation difference is between 1 and 2 inches.

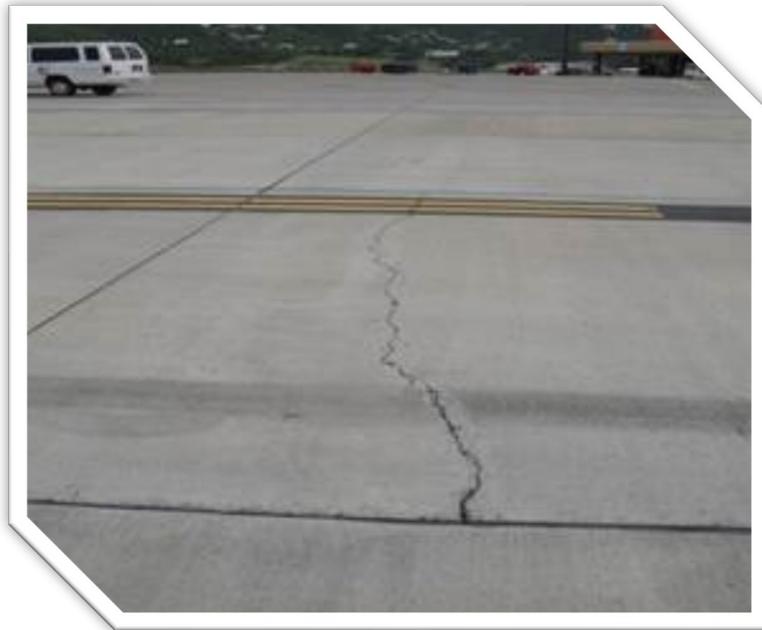
8. Linear Cracking

Cracks that divide slab into two or three pieces.

Low Severity: Crack is less than ½ inch wide.

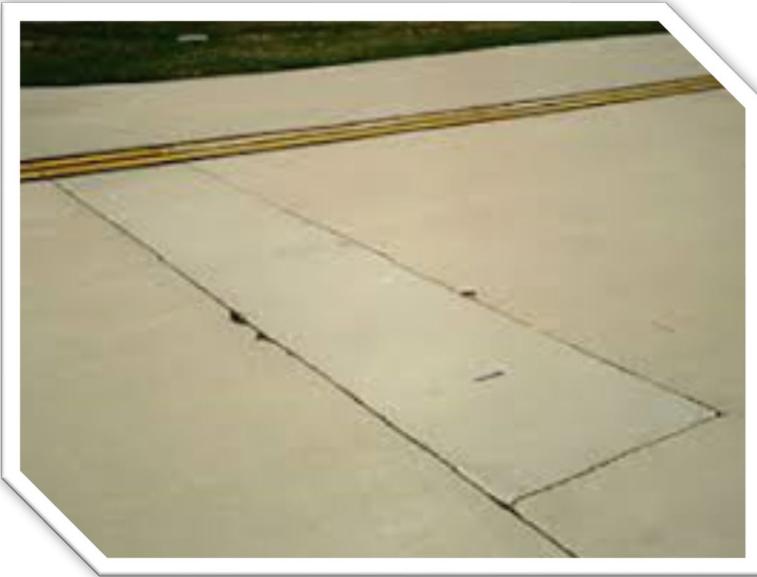
9. Large Patch

Patch that is larger than 5.5 sq ft.

Low Severity: Patch has little or no deterioration.

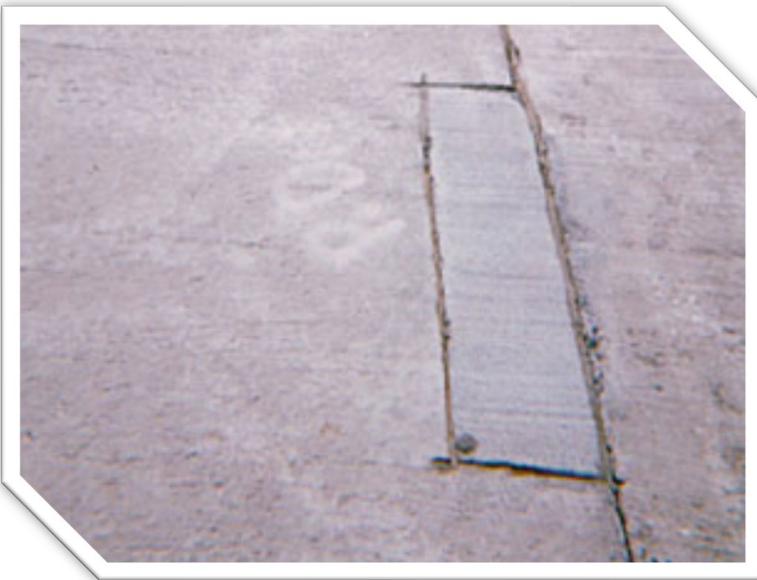
10. Small Patch

Patch that is smaller than 5.5 sq ft.

Low Severity: Patch has little or no deterioration.

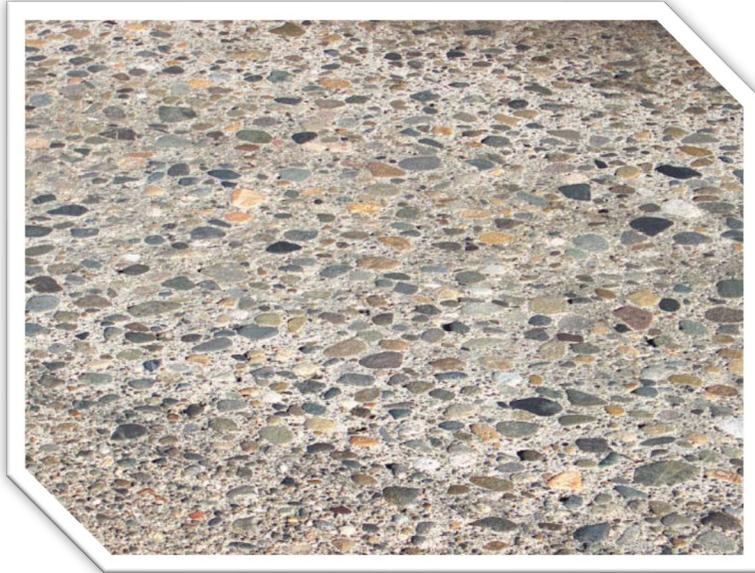
11. Polished Aggregate

Distress where traffic smooths the pavement surface so friction is diminished and cars can slide.

There are no Severity Levels for this distress.

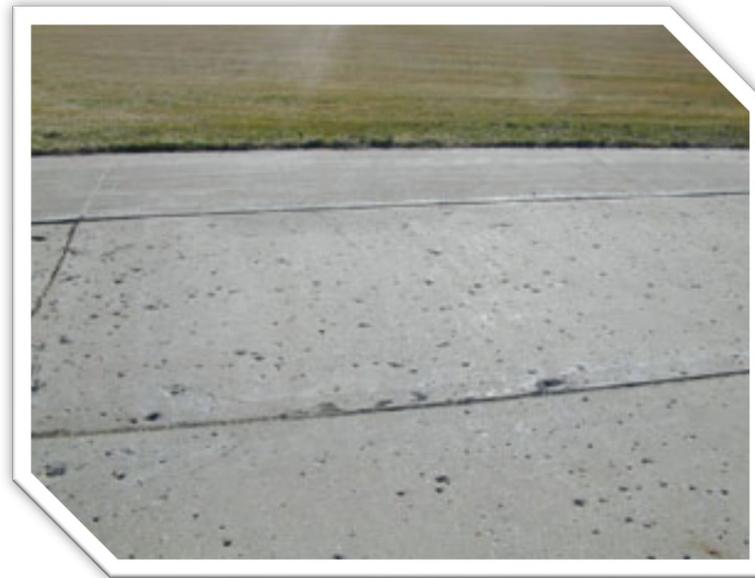
12. Popouts

Small piece of pavement that breaks loose from surface.

There are no Severity Levels for this distress, however popouts must cover 3 per sq. meter of the slab.

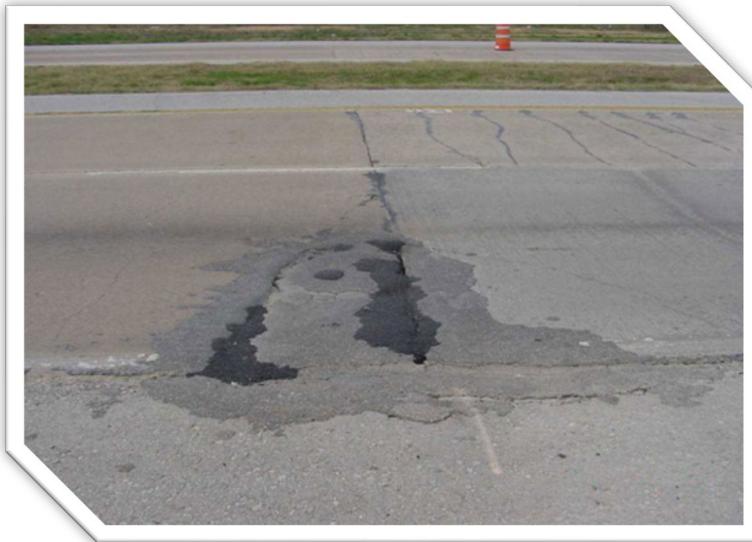
13. Pumping

Ejection of material from slab foundation through joints or cracks along with water.

There are no Severity Levels for this distress.

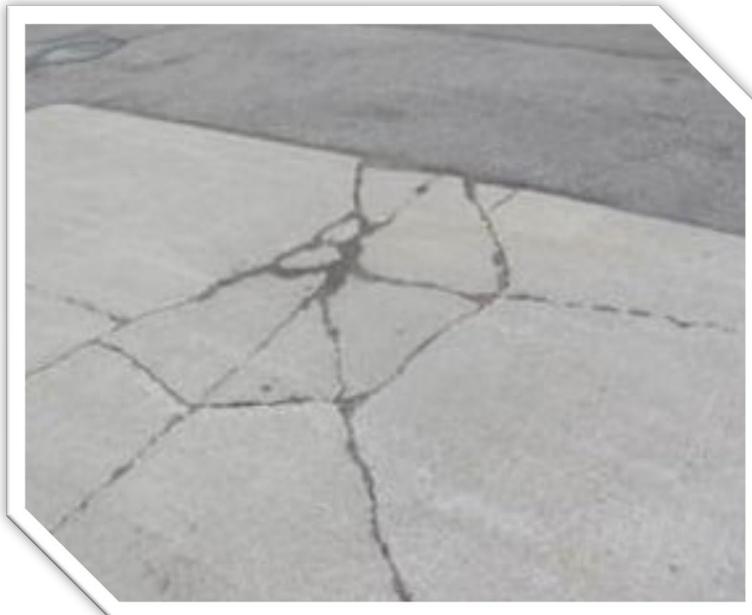
14. Punchout

Localized area of a slab that is broken into many pieces.

Severity is determined by the following matrix.

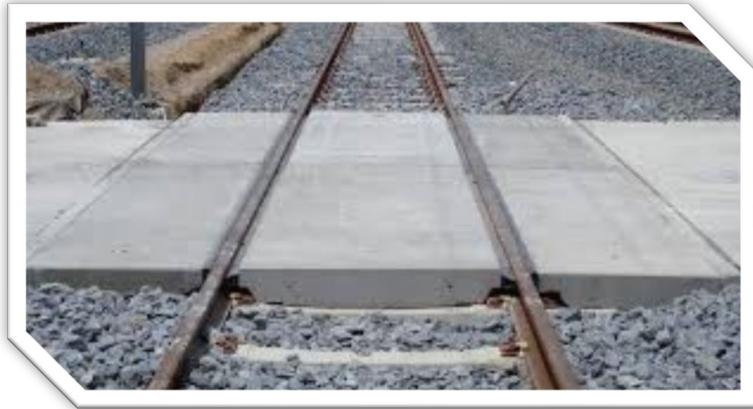
15. Railroad Crossing

Pavement distresses caused by railroad crossings.

Severity is determined by the extent to which ride quality is diminished.

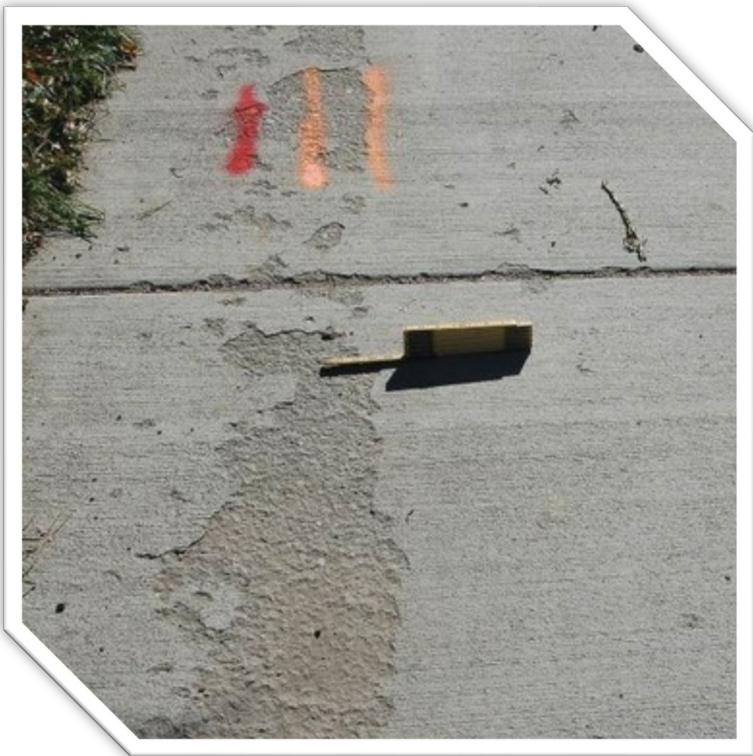
16. Map Cracking, Scaling

Map cracking refers to a network of shallow, fine cracks. This can lead to breakdown of slab surface (Scaling).

Low Severity: Map cracking exists over most of slab area, but there is only minor scaling present.

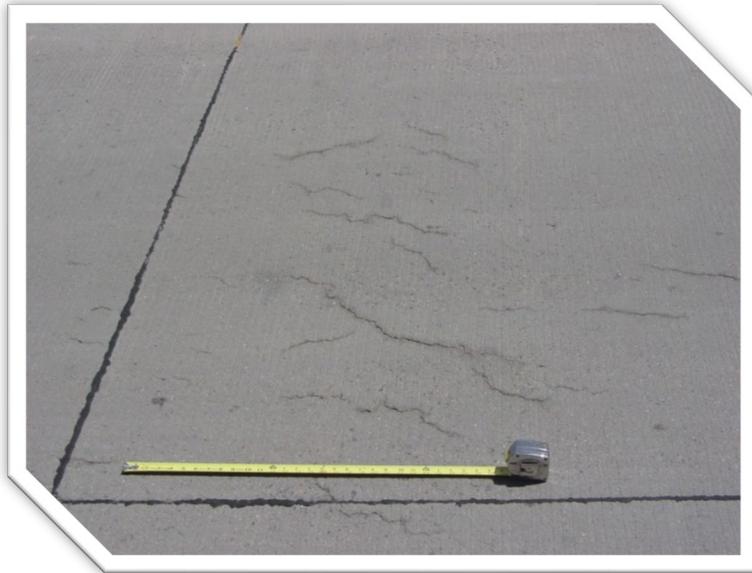
17. Shrinkage Cracking

Short hairline cracks formed during setting of concrete.

There are no Severity Levels for this distress.

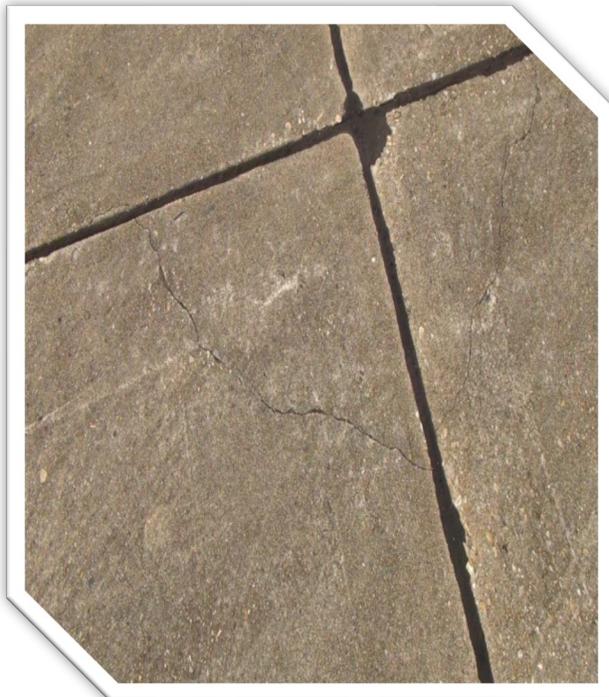
18. Corner Spall

Breakdown of slab at corner. Crack angles toward joint as opposed to straight down.

Severity is determined by the following matrix.

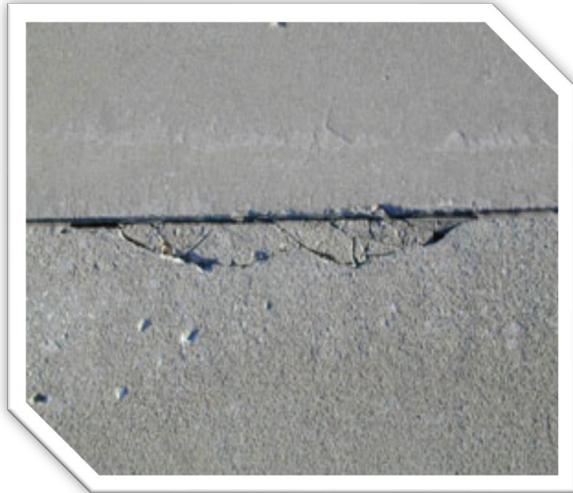
19. Joint Spall

Breakdown of slab at a joint. Crack angles toward joint as opposed to straight down.

Severity is determined by the following matrix.
