Arborist Report

PROTECTED TREE REPORT
for
the Meadows at Bailey Canyon Project
City of Sierra Madre, California

DUDEK
38 North Marengo Avenue
Pasadena, California 91101
Contact: Ryan Allen
626.658.0070
Certified Arborist #WE10316-A

JANUARY 2022

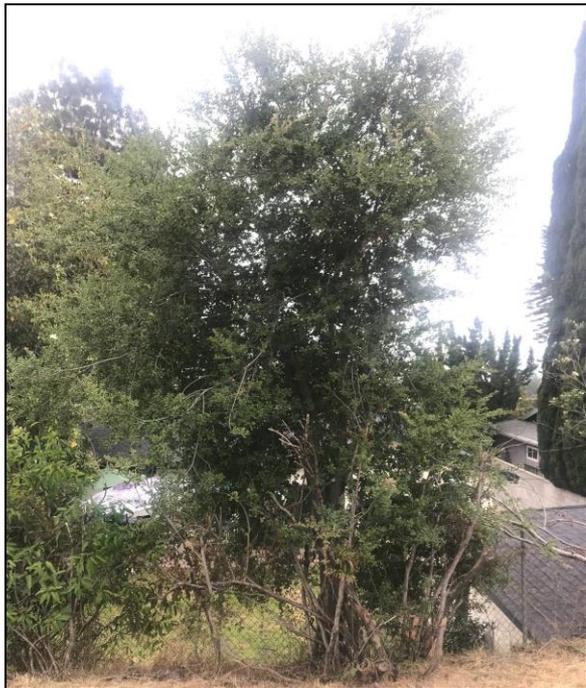
| Tree No. | Botanical Name | Common Name | Impact | DBH (Inches) | Stems | Stem 1 | Stem 2 | Stem 3 | Stem 4 | Stem 5 | Height (Feet) | Width (Feet) | Health | Structure | Protected | Notes | Latitude | Longitude |
|---|---|---|---|---|---|---|---|---|---|---|---|---|---|---|---|---|---|---|
| 1 | <i>Quercus agrifolia</i> | coast live oak | Removal | 8 | 1 | 8 | 0 | 0 | 0 | 0 | 20 | 12 | Fair | Fair | Yes | | 34.170836 | -118.0633 |

Photo 5. Photograph of protected coast live oak tree #1.

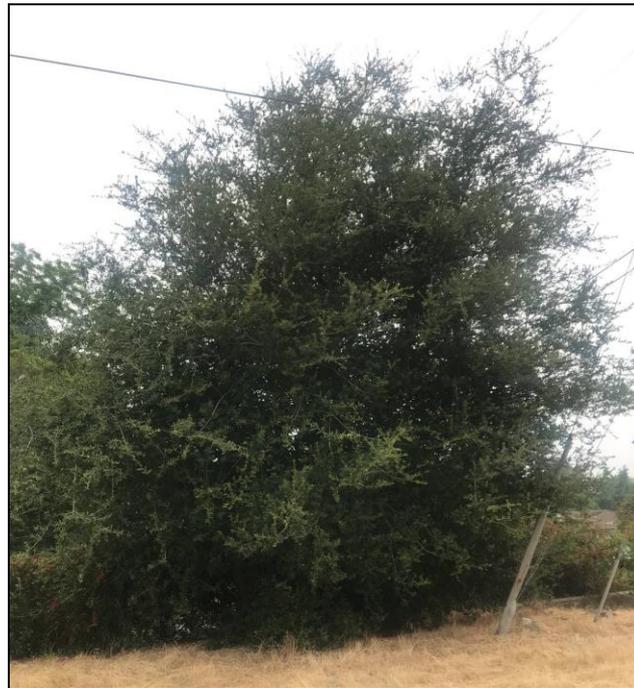
| Tree No. | Botanical Name | Common Name | Impact | DBH (Inches) | Stems | Stem 1 | Stem 2 | Stem 3 | Stem 4 | Stem 5 | Height (Feet) | Width (Feet) | Health | Structure | Protected | Notes | Latitude | Longitude |
|---|---|---|---|---|---|---|---|---|---|---|---|---|---|---|---|---|---|---|
| 2 | <i>Quercus agrifolia</i> | coast live oak | Removal | 33 | 5 | 8 | 7 | 6 | 6 | 6 | 25 | 20 | Good | Fair | Yes | | 34.170867 | -118.0627 |

Photo 6. Photograph of protected coast live oak tree #2.

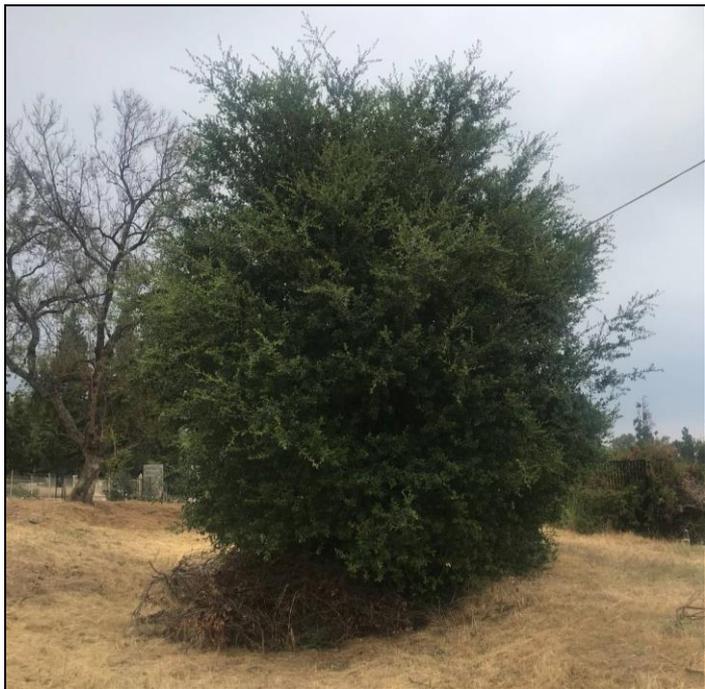
| Tree No. | Botanical Name | Common Name | Impact | DBH (Inches) | Stems | Stem 1 | Stem 2 | Stem 3 | Stem 4 | Stem 5 | Height (Feet) | Width (Feet) | Health | Structure | Protected | Notes | Latitude | Longitude |
|---|---|---|---|---|---|---|---|---|---|---|---|---|---|---|---|---|---|---|
| 3 | <i>Quercus agrifolia</i> | coast live oak | Removal | 26 | 3 | 9 | 9 | 8 | 0 | 0 | 25 | 20 | Good | Fair | Yes | | 34.170907 | -118.0624 |

Photo 7. Photograph of protected coast live oak tree #3.

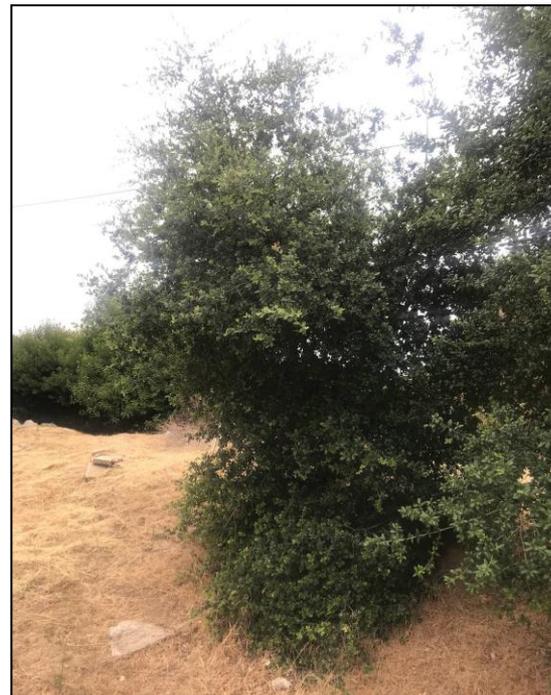
| Tree No. | Botanical Name | Common Name | Impact | DBH (Inches) | Stems | Stem 1 | Stem 2 | Stem 3 | Stem 4 | Stem 5 | Height (Feet) | Width (Feet) | Health | Structure | Protected | Notes | Latitude | Longitude |
|---|---|---|---|---|---|---|---|---|---|---|---|---|---|---|---|---|---|---|
| 4 | <i>Quercus agrifolia</i> | coast live oak | Removal | 12 | 2 | 6 | 6 | 0 | 0 | 0 | 15 | 15 | Fair | Fair | Yes | | 34.170901 | -118.0624 |

Photo 8. Photograph of protected coast live oak tree #4.

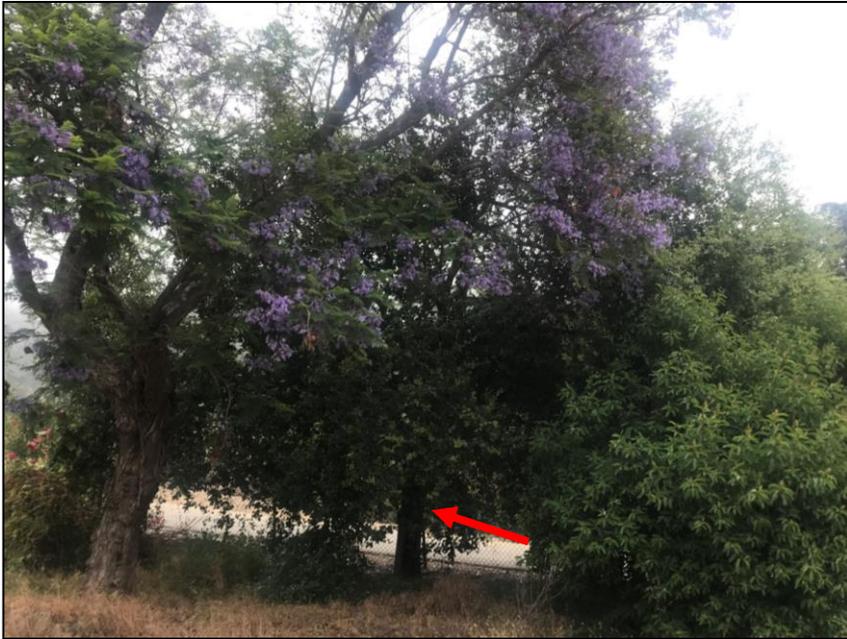
Photo 9. Photograph of protected coast live oak tree #15.

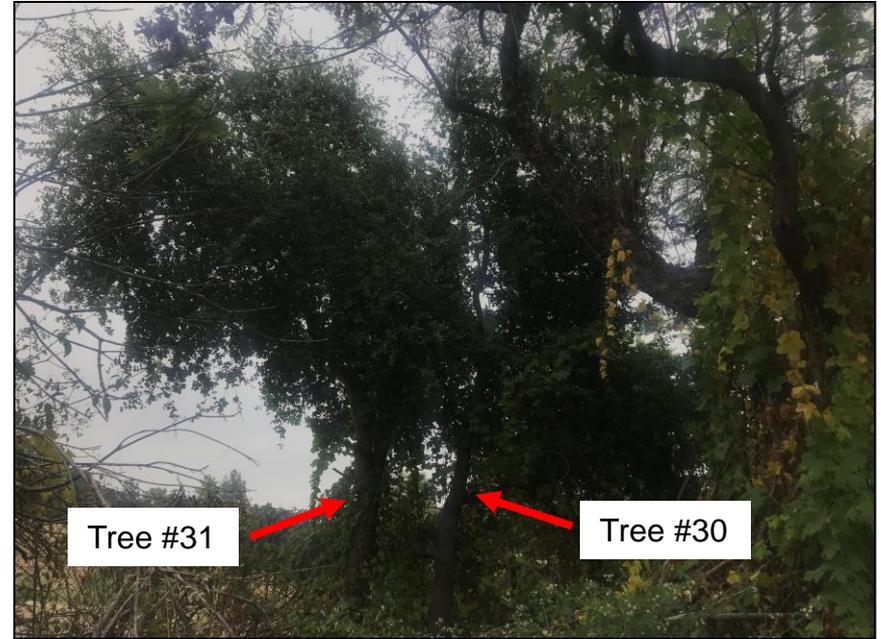
Photo 10. Photograph of protected coast live oak trees #30 and #31.

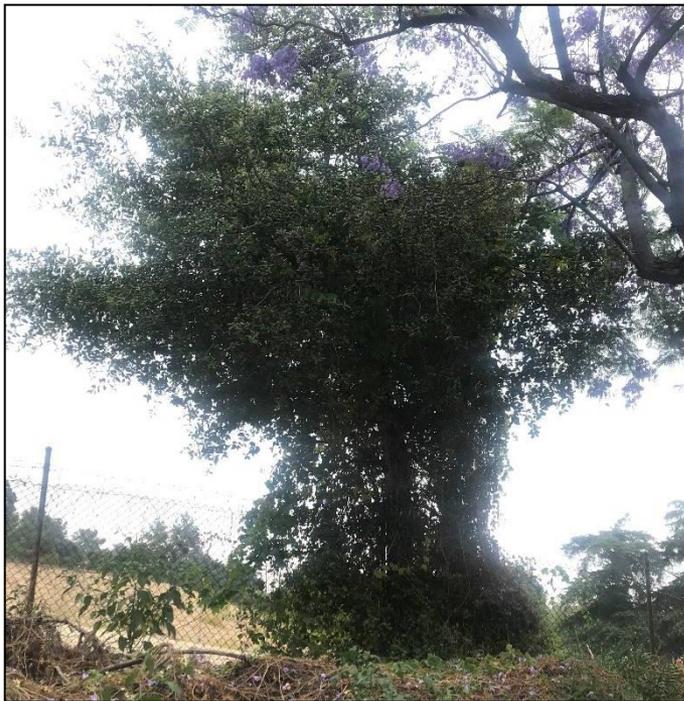
Photo 11. Photograph of protected coast live oak tree #33.

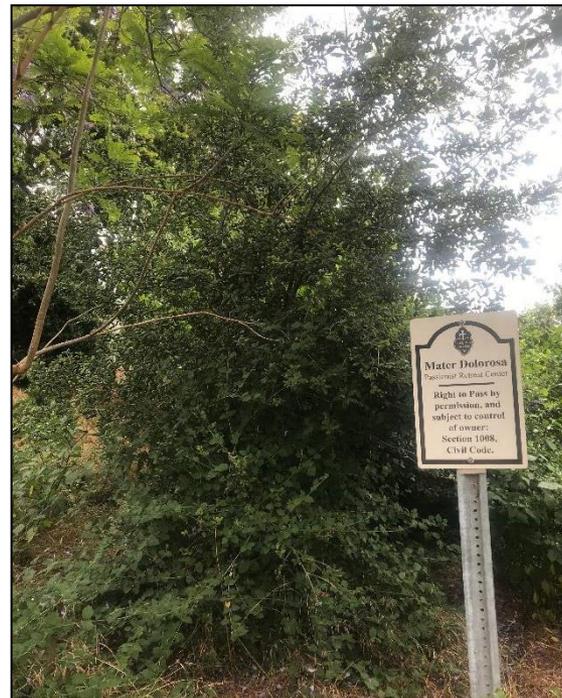
Photo 12. Photograph of protected coast live oak tree #43.

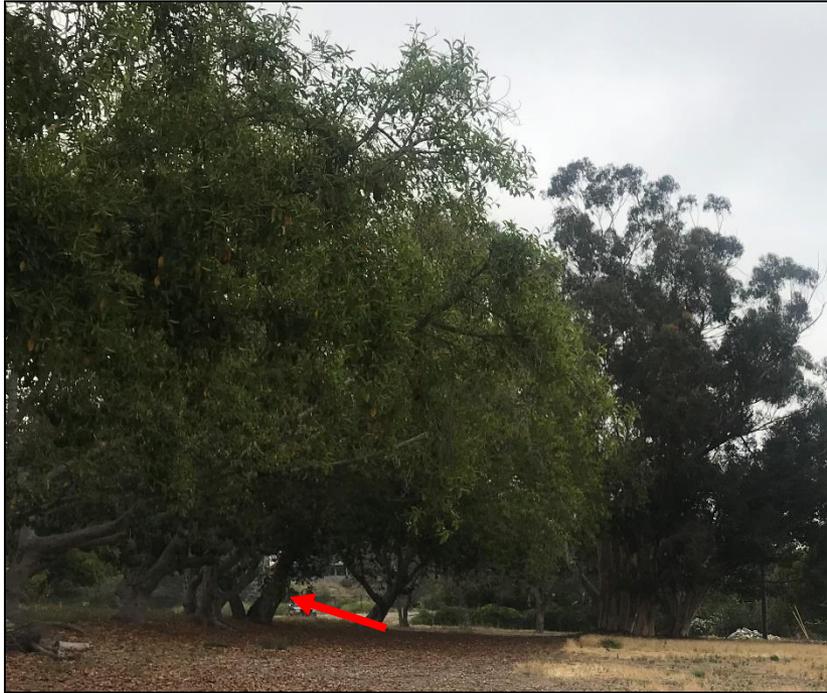
Photo 13. Representative photograph of protected coast live oak tree #61.

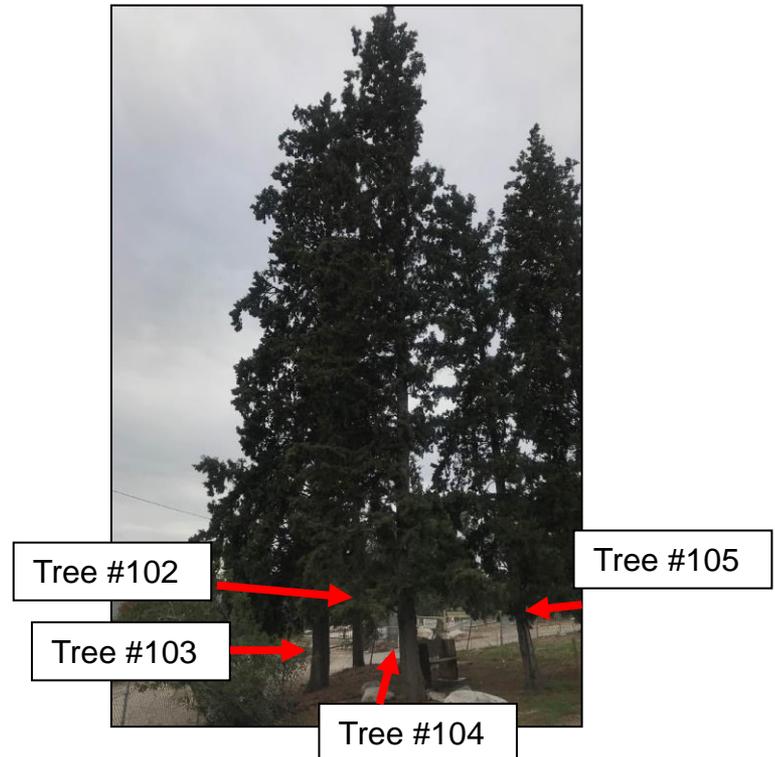
Photo 14. Representative photograph of protected trees nos. 102, 103, 104, 105.

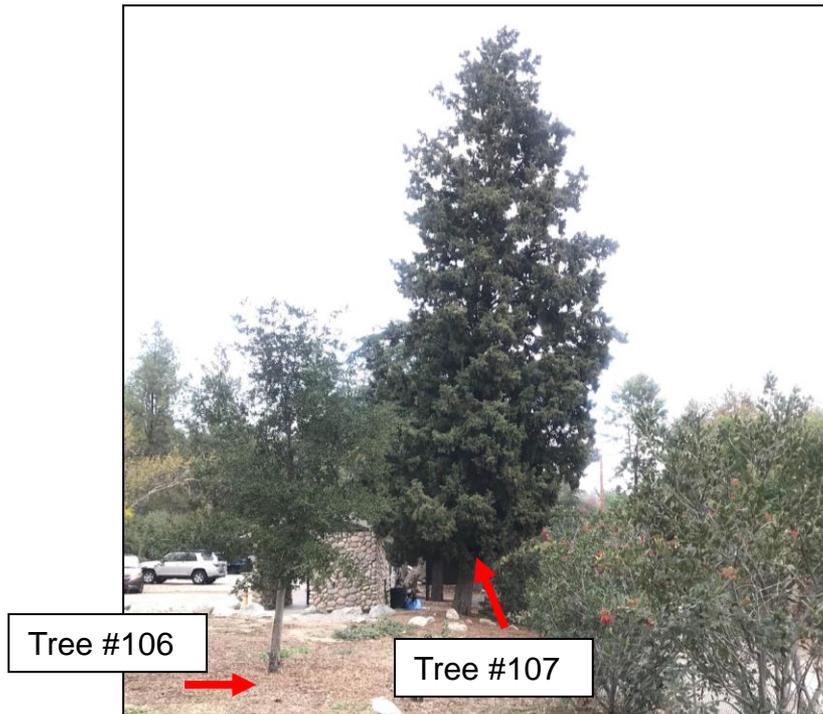
Photo 15. Representative photograph of protected tree nos. 106 and 107.

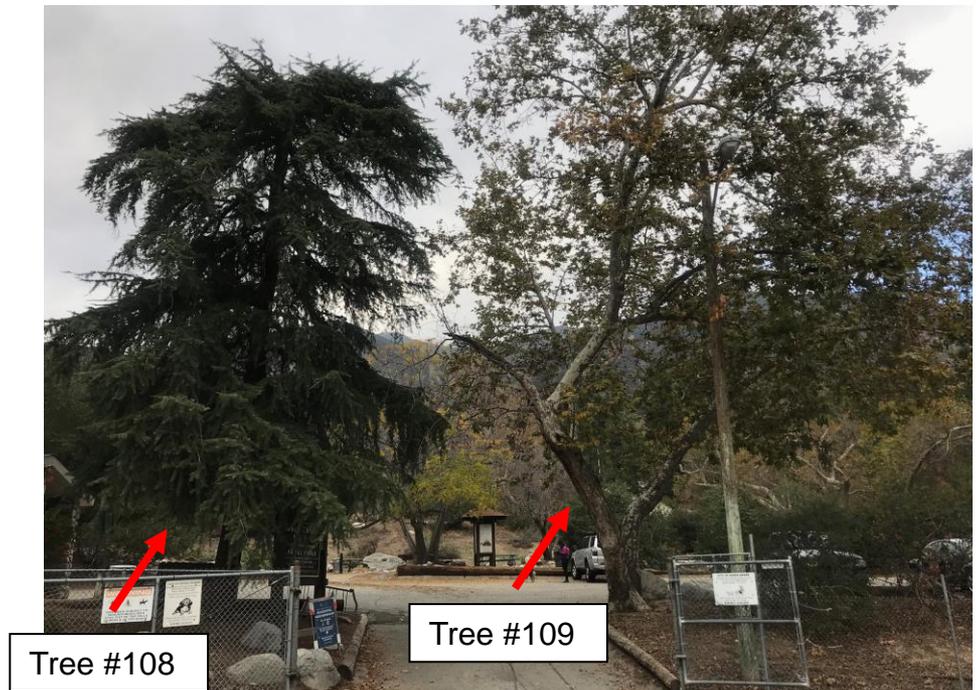
Photo 16. Representative photograph of protected trees nos. 108 and 109.

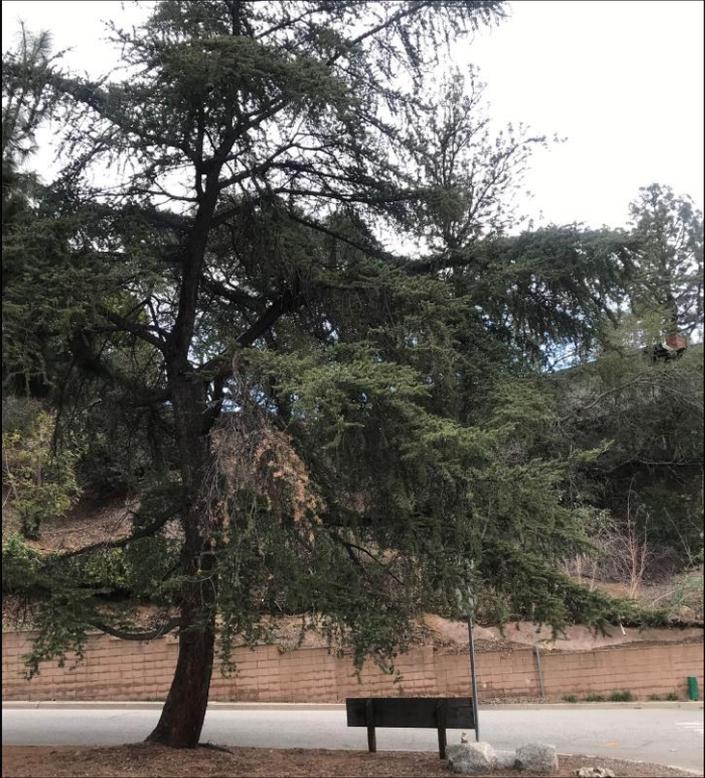
Photo 18. Representative photograph of protected tree no. 117.
