Historical Evaluation Memorandum
for the Record

April 6, 2018
Job Number: 2285-001
Historical Evaluation for
935 and 965 E. Grand View Avenue, Sierra Madre, CA 91024

SUBJECT: Historical Evaluation for 935 and 965 E. Grand View
Avenue, Sierra Madre, California

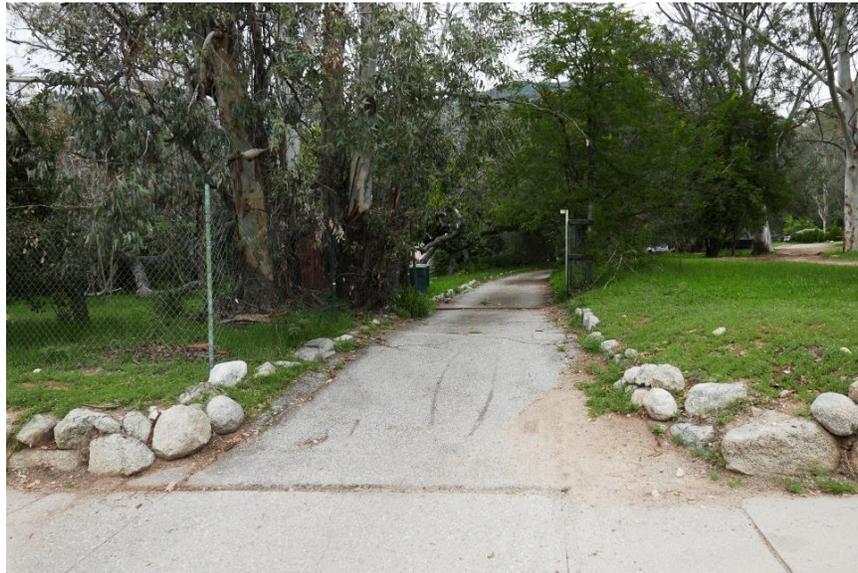
Located at 935 E. Grand View Avenue, Sierra Madre, California (APN 5764-001-017), the subject property is bordered by wooded lands to the north, the property at 965 E. Grand View Avenue to the east, E. Grand View Avenue to the south, and single-family residences to the west. The property is accessed via a paved driveway lined with stones and a grove of avocado trees (*Persea Americana*) that were planted circa 1940–1950 (Figure 4, *View of 935 E. Grand View Avenue Driveway*).

Figure 4. View of 935 E. Grand View Avenue Driveway
SOURCE: Sapphos Environmental, Inc., 2018

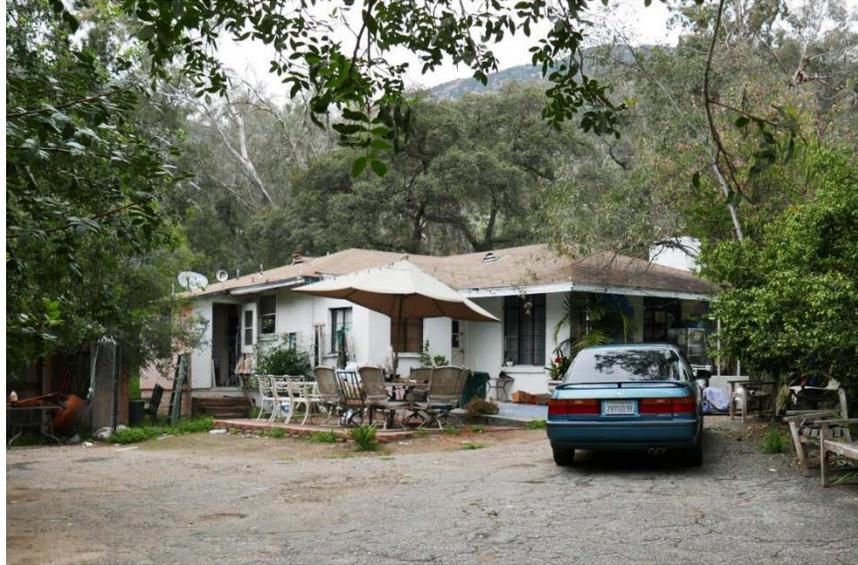
On the property located at 935 E. Grand View Avenue are a 1,700-square-foot single-family residence (residence No. 1) and a 600-square-foot shed (shed No. 1). The residence is a post-war building constructed in 1947 and is laid out in a plan oriented south to north. The building was originally Ranch style but has received numerous alterations and additions over the decades which greatly altered the building's appearance, and the building is now vernacular. The building originally was constructed with an 'L'-shaped footprint, but currently has a 'U'-shaped footprint due to alterations. The residence was constructed of bricks, which are still exposed, and has a hipped roof with deeply overhanging boxed eaves. Additions are identifiable by their stucco exterior and shed-style roofs. Fenestration is a combination of original wood double-hung windows and aluminum casement windows (Figure 5, *General View of Residence No. 1 from the South*).

Figure 5. General View of Residence No. 1 from the South
SOURCE: *Sapphos Environmental, Inc., 2018*

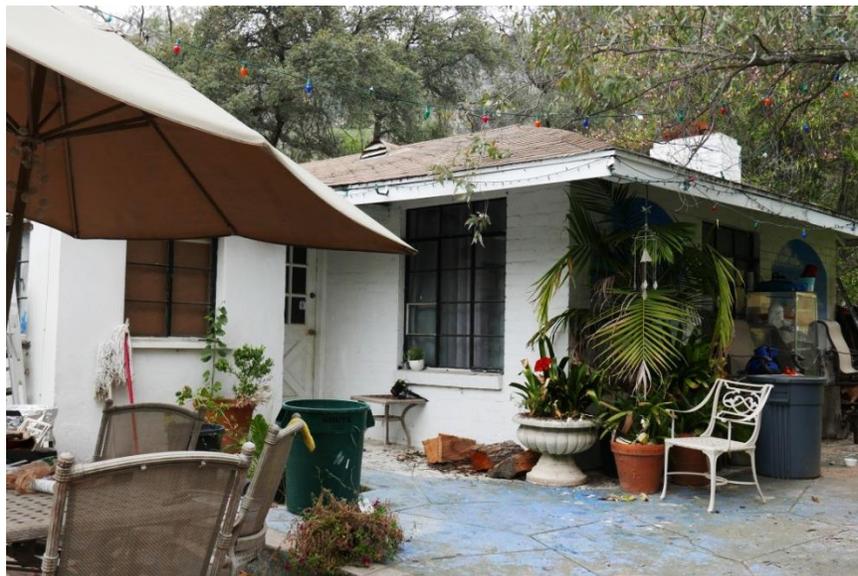
The entrance to the residence is accessed to the south via a patio and recessed entrance. The primary door has a 6-light window to provide natural light. The southernmost ell of the building is an addition, as visible from the stucco exterior and shed-style roof that sits upon the edge of the original hipped roof. The entrance is flanked on one side by the original building with brick exterior and 18-light aluminum windows and the other side by an addition with shed-style roof and 6-light aluminum casement windows (Figure 6, *View of Primary Entrance, Residence No. 1, 935 E. Grand View Avenue*).

Figure 6. View of Primary Entrance, Residence No. 1, 935 E. Grand View Avenue
SOURCE: *Sapphos Environmental, Inc., 2018*

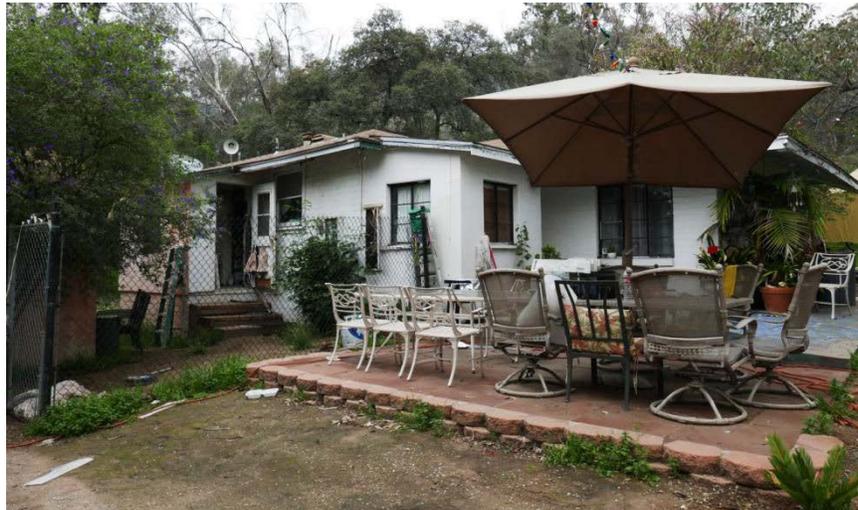
addition is discernible from the original building by its stucco exterior, and is accessed via three wood steps. The door is kitty-corner to an original, wood double-hung window. This window starkly contrasts with altered windows apparent on both additions and the original building, which are aluminum fixed and casement windows. Various metal vents that provide passive airflow to the attic are visible from this façade (Figure 7, *View of Primary [Southern] Façade, Residence No. 1, 935 E. Grand View Avenue*).

Figure 7. View of Primary (Southern) Façade, Residence No. 1, 935 E. Grand View Avenue
SOURCE: *Sapphos Environmental, Inc., 2018*

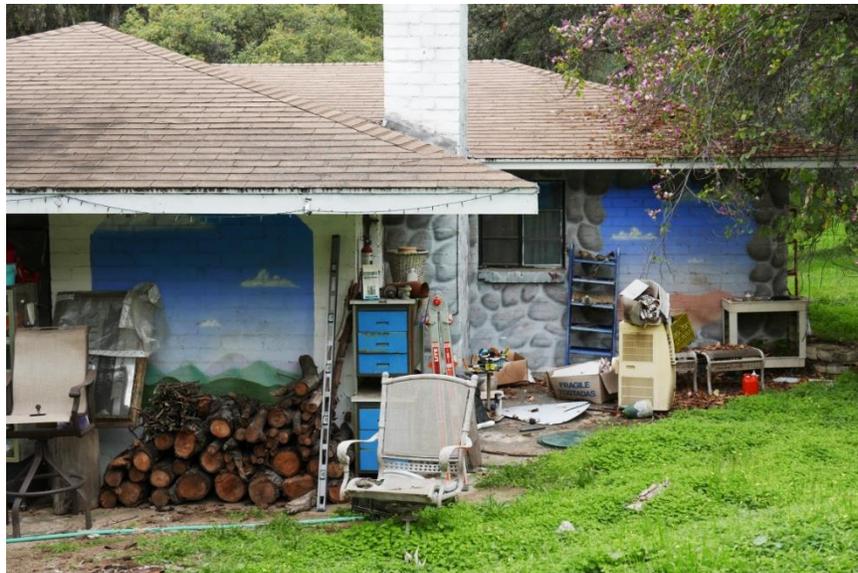
The eastern façade does not appear to feature any additions, but instead evidences the residence's double-hipped roof and brick exterior. However, an aluminum casement window along this façade with windowsill was likely an alteration. The chimney is located along the northern façade but is visible from this side. The exterior of the property was painted to resemble stone and vistas at an unknown date (Figure 8, *View of Eastern Façade, Residence No. 1, 935 E. Grand View Avenue*).

Figure 8. View of Eastern Façade, Residence No. 1, 935 E. Grand View Avenue
SOURCE: *Sapphos Environmental, Inc., 2018*

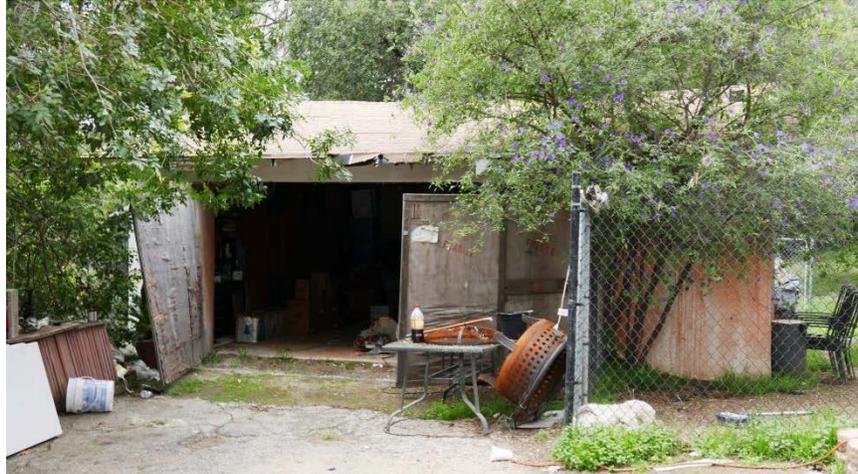
Shed No. 1 is located perpendicular and to the southwest of the residence and measures approximately 600 square feet. The shed is constructed of wood with a stucco exterior, has a shingle-clad gable roof, concrete floors, and wood doors. The roof eaves have sustained damage over time and the wood doors are only partially attached to the building (Figure 9, *View of Shed No. 1, 935 E. Grand View Avenue*).

Figure 9. View of Shed No. 1, 935 E. Grand View Avenue
SOURCE: *Sapphos Environmental, Inc., 2018*

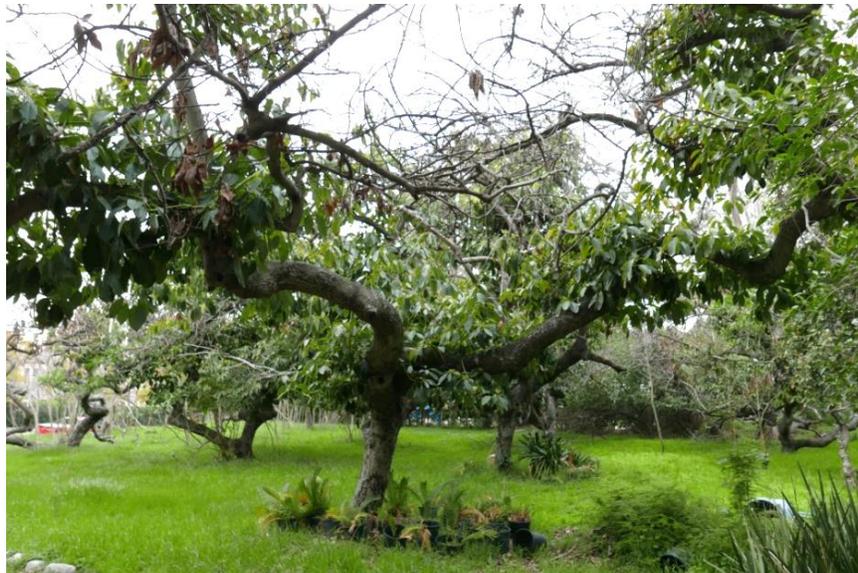
Figure 10. View of Yard, 935 E. Grand View Avenue
SOURCE: *Sapphos Environmental, Inc., 2018*

The front yard faces E. Grand View Avenue and features fruit trees that were planted in the late 1940s or early 1950s and appears to no longer be maintained (Figure 10, *View of Yard, 935 E. Grand View Avenue*).

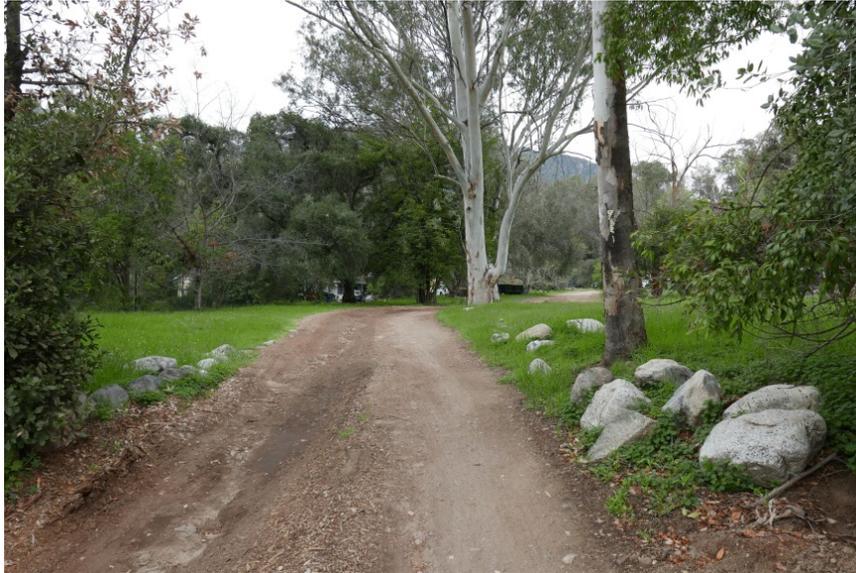
Figure 11. View of 965 E. Grand View Avenue Driveway
SOURCE: *Sapphos Environmental, Inc., 2018*

Located at 965 E. Grand View Avenue, Sierra Madre, California (APN 5764-001-018), the subject property is bordered by wooded lands to the north, single-family residences and Sierra Madre Search and Rescue on Stonehouse Road to the east, E. Grand View Avenue to the south, and the property at 935 E. Grand View Avenue to the west. The property is accessed via a dirt driveway lined with stones and trees (Figure 11, *View of 965 E. Grand View Avenue Driveway*).

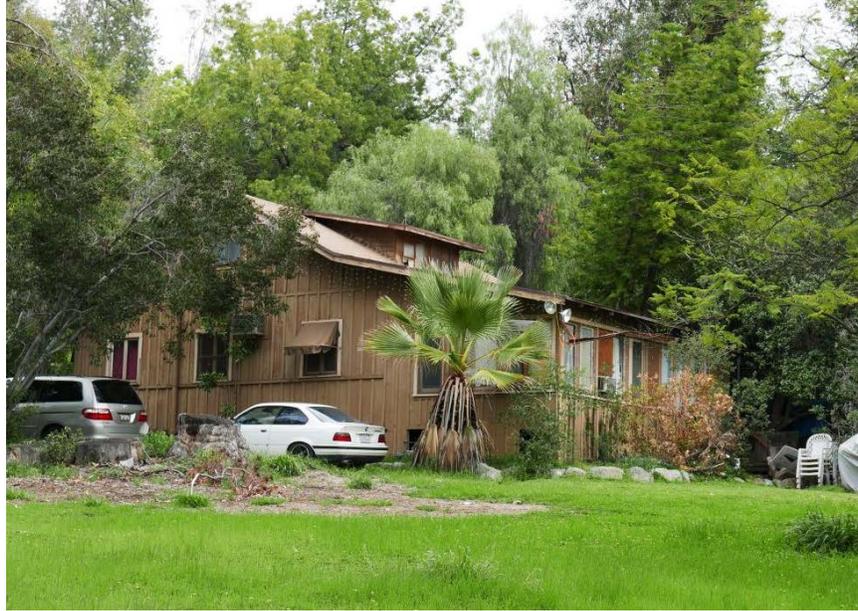
The building has a rectangular footprint, broken gable roof, and central sleeping porch. It was likely originally constructed in the turn-of-the-century cabin style with some Craftsman-style alterations. However, the property no longer retains this appearance due to alterations (Figure 12, *General View of Residence No. 2 from Southwest, 965 E. Grand View Avenue*).

Figure 12. General View of Residence No. 2 from Southwest, 965 E. Grand View Avenue
SOURCE: *Sapphos Environmental, Inc., 2018*

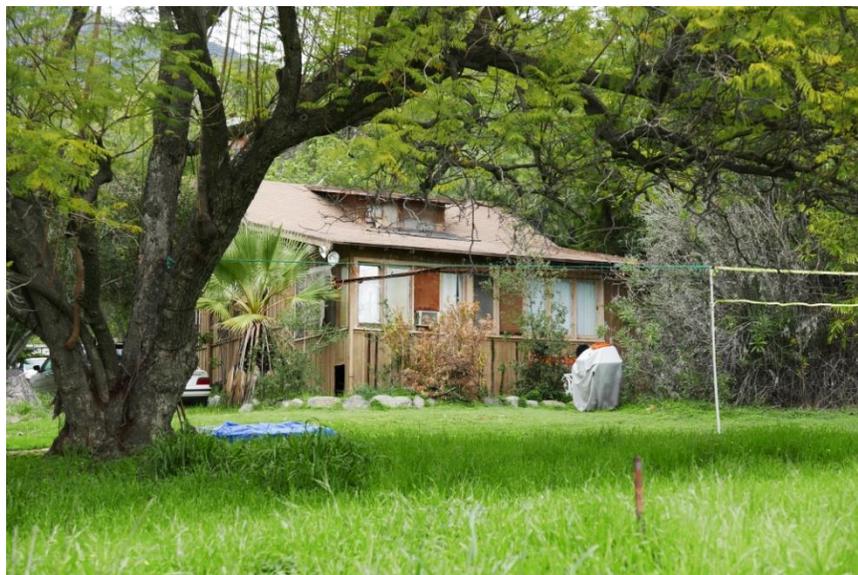
The primary (southern) façade of the residence features the central sleeping porch that was possibly an enclosure of an earlier porch; this alteration likely occurred in the 1910–1920s. An original dormer with a shed roof and wood shingle cladding is centered on the broken-gable roof. The exterior of the building was re-clad in board-and-batten siding at an unknown date; as visible from the dormer, the building was likely originally clad in wood shingles. Fenestration is composed of a ribbon of wood mullion casement windows that wraps around the three-sided sleeping porch and dormer (Figure 13, *View of Primary [Southern] Façade, Residence No. 2, 965 E. Grand View Avenue*).

Figure 13. View of Primary (Southern) Façade, Residence No. 2, 965 E. Grand View Avenue
SOURCE: *Sapphos Environmental, Inc., 2018*

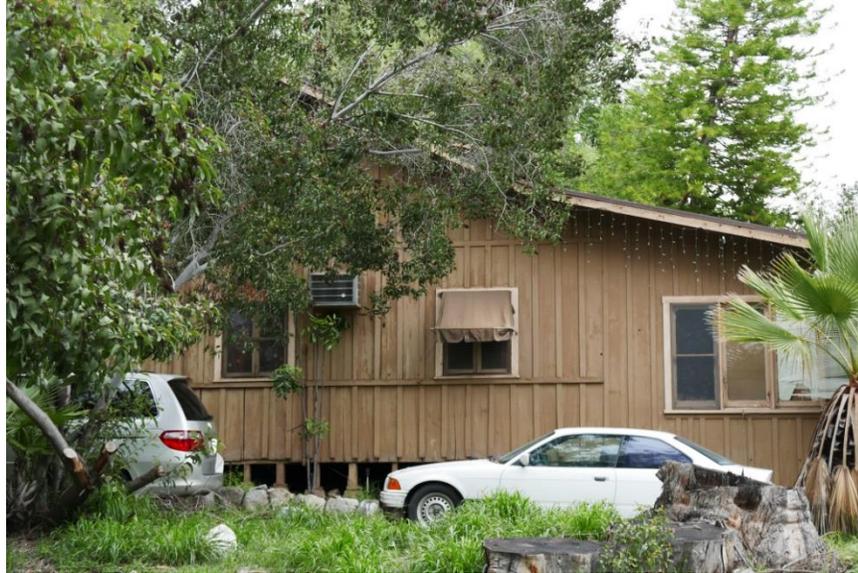
Along the western side of the building, the board-and-batten siding is divided by a number of horizontal boards. Fenestration is comprised of paired casement windows with wood mullions. A drain pipe painted to match the exterior is located down the center of this façade (Figure 14, *View of Western Façade, Residence No. 2, 965 E. Grand View Avenue*).

Figure 14. View of Western Façade, Residence No. 2, 965 E. Grand View Avenue
SOURCE: *Sapphos Environmental, Inc., 2018*

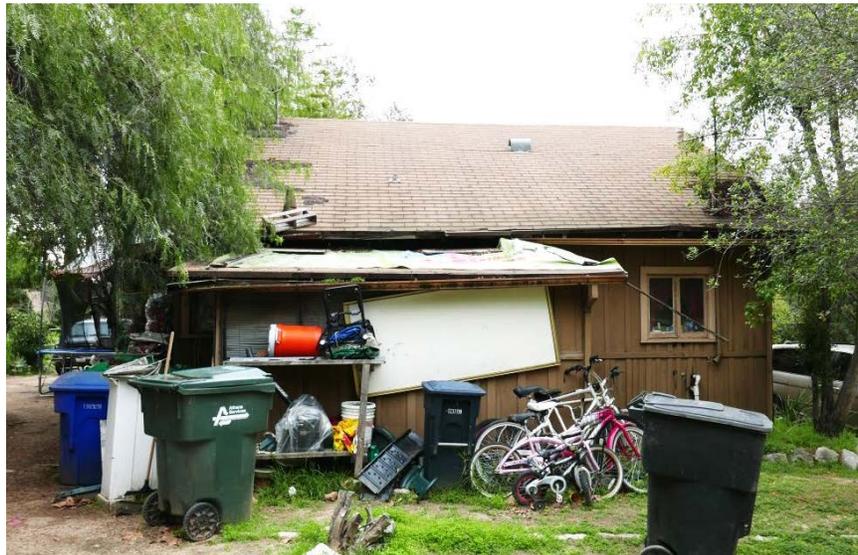
The northern façade features what is likely an addition to the building. This addition is shorter than the original building and features a shed roof. Windows along this façade are mostly sliding windows (Figure 15, *View of Northern Façade, Residence No. 2, 965 E. Grand View Avenue*).

Figure 15. View of Northern Façade, Residence No. 2, 965 E. Grand View Avenue
SOURCE: *Sapphos Environmental, Inc., 2018*

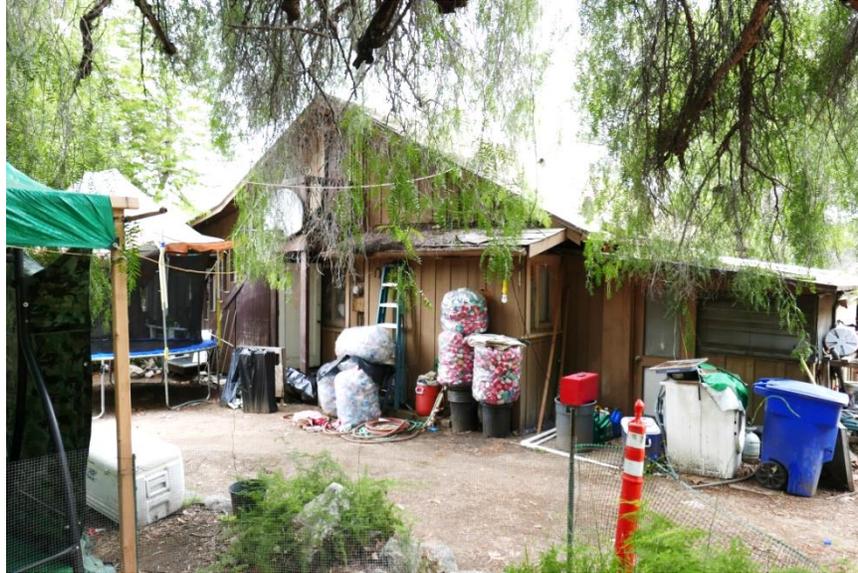
entrance to the second story along this façade, with an additional entrance tucked beneath it. Although the property may have originally had an exterior, exposed staircase, this staircase appears to be newer, likely dates to the 1960s, and appears to be an addition (Figure 16, *View of Eastern Façade, Residence No. 2, 965 E. Grand View Avenue*).

Figure 16. View of Eastern Façade, Residence No. 2, 965 E. Grand View Avenue
SOURCE: *Sapphos Environmental, Inc., 2018*

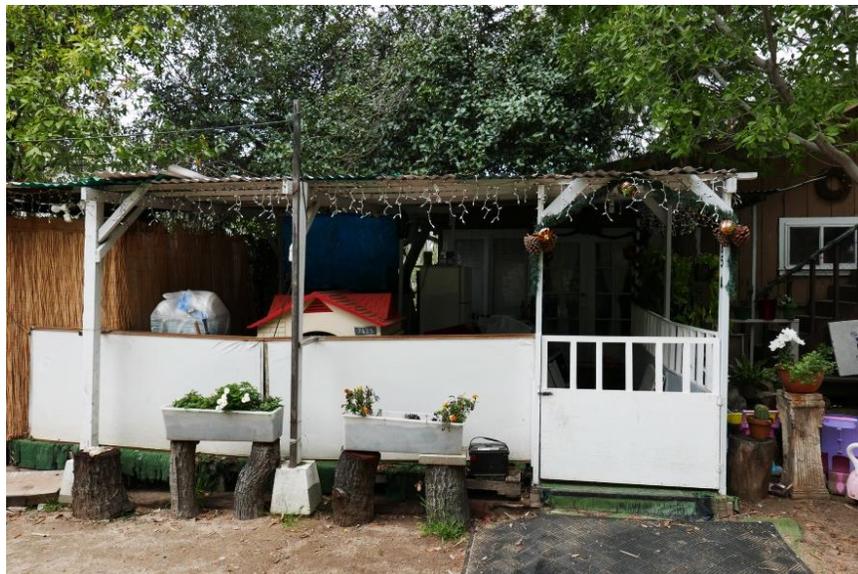
The southeastern corner of the residence includes a roughly-constructed shelter that provides entrance to the sleeping porch. This shelter is built of wood posts with waist-high plywood walls and a flat, corrugated metal roof (Figure 17, *View of Southeastern Corner, Residence No. 2, 965 E. Grand View Avenue*). It is a modern alteration to the building. Residence No. 2 has received numerous alterations over the past 100+ years and is in fairly poor condition due to neglect.

Figure 17. View of Southeastern Corner, Residence No. 2, 965 E. Grand View Avenue
SOURCE: *Sapphos Environmental, Inc., 2018*

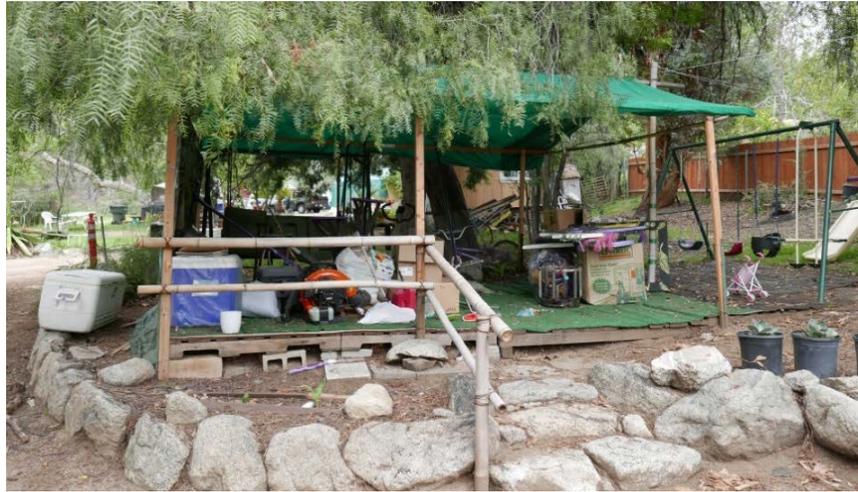
Located just north of residence No. 2 is gazebo No. 1. The gazebo measures approximately 250 square feet and has a floor constructed of wood pallets set on concrete blocks, bamboo poles, and a tiered tarp roof. The gazebo is a modern construction but likely supplanted an earlier gazebo, as evidence from the stone platform on which it is constructed. This platform features a ring of large stones and three central stones that serve as steps (Figure 18, *View of Gazebo No. 1, 965 E. Grand View Avenue*). The gazebo is modern and does not date to the initial development of this property.

Figure 18, View of Gazebo No. 1, 965 E. Grand View Avenue
SOURCE: *Sapphos Environmental, Inc., 2018*

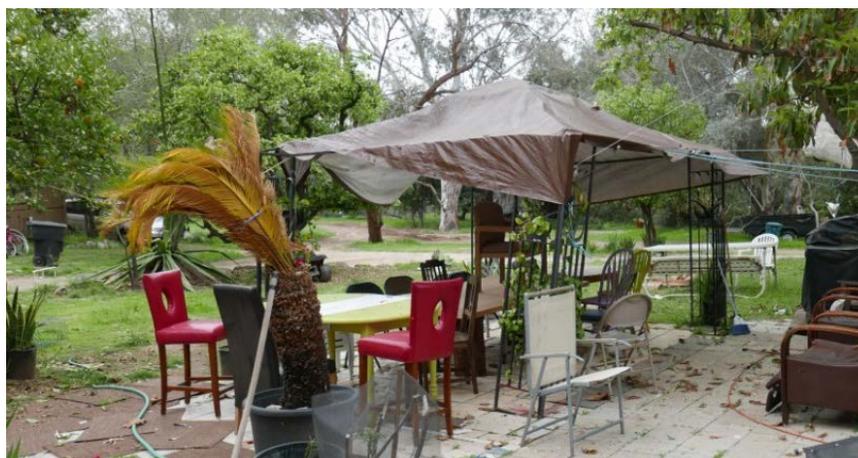
Gazebo No. 2 is situated in the central region of the parcel and to the immediate west of residence No. 3. This gazebo also measures approximately 250 square feet and is a pre-fabricated metal structure with ornamented posts covered by a plastic tarp. The gazebo sits upon concrete pavers (Figure 19, *View of Gazebo No. 2, 965 E. Grand View Avenue*). The gazebo is modern and does not date to the initial development of the property.

Figure 19. View of Gazebo No. 2, 965 E. Grand View Avenue
SOURCE: *Sapphos Environmental, Inc., 2018*

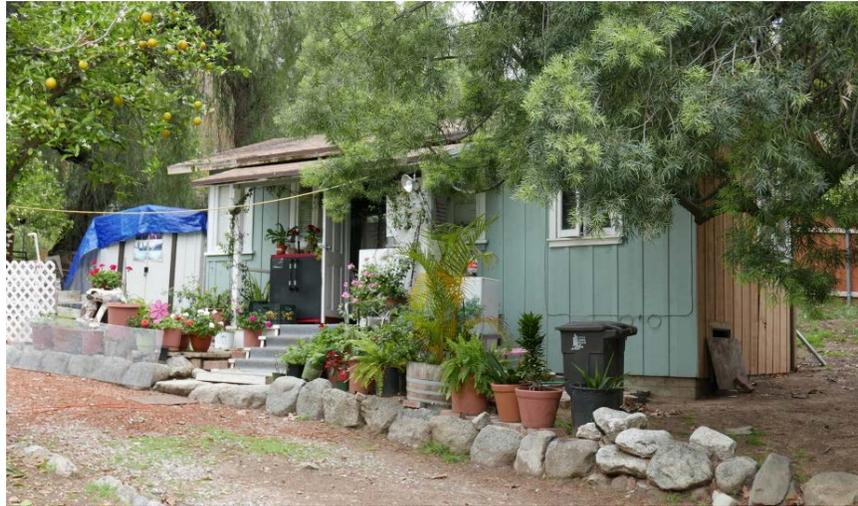
Located north of residence No. 1, east of gazebo No. 2 and south of shed No. 2, is residence No. 3. Residence No. 3 measures approximately 1,400 square feet, is vernacular, and was likely constructed in the 1930s based upon the style and materials of the building. The residence has a gable roof clad in shingles and the exterior is clad in board and batten siding. The stone wall lining the driveway continues along the front side of the residence (Figure 20, *General View of Residence No. 3 from Southwest, 965 E. Grand View Ave*).

Figure 20. General View of Residence No. 3 from Southwest, 965 E. Grand View Avenue
SOURCE: *Sapphos Environmental, Inc., 2018*

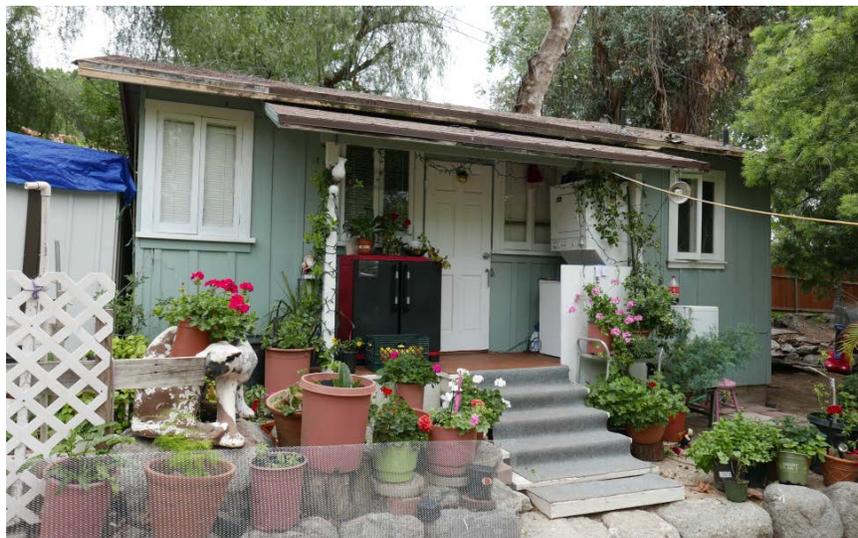
Along the primary façade, the building has a sheltered entrance porch that features squared wood columns and a shed roof. The entrance is a paneled wood door accessed by a stairway. Fenestration is comprised of paired wood casement windows (Figure 21, *View of Primary [Western] Façade, Residence No. 3, 965 E. Grand View Ave*).

Figure 21. View of Primary (Western) Façade, Residence No. 3, 965 E. Grand View Avenue
SOURCE: *Sapphos Environmental, Inc., 2018*

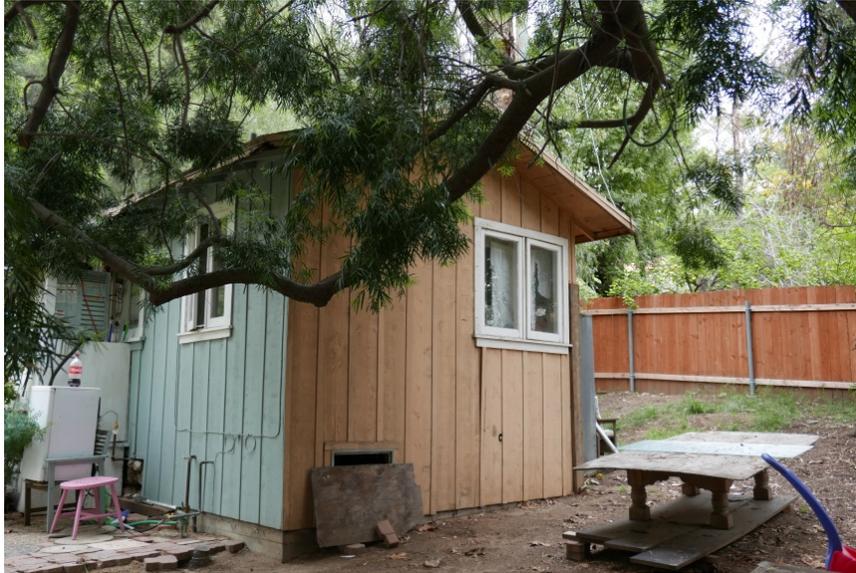
The southern façade of residence No. 3 features a roof gable end, board and batten siding, a paired wood casement window, and vent to provide passive air flow (Figure 22, *View of Southern Façade, Residence No. 3, 965 E. Grand View Avenue*).

Figure 22. View of Southern Façade, Residence No. 3, 965 E. Grand View Avenue
SOURCE: *Sapphos Environmental, Inc., 2018*

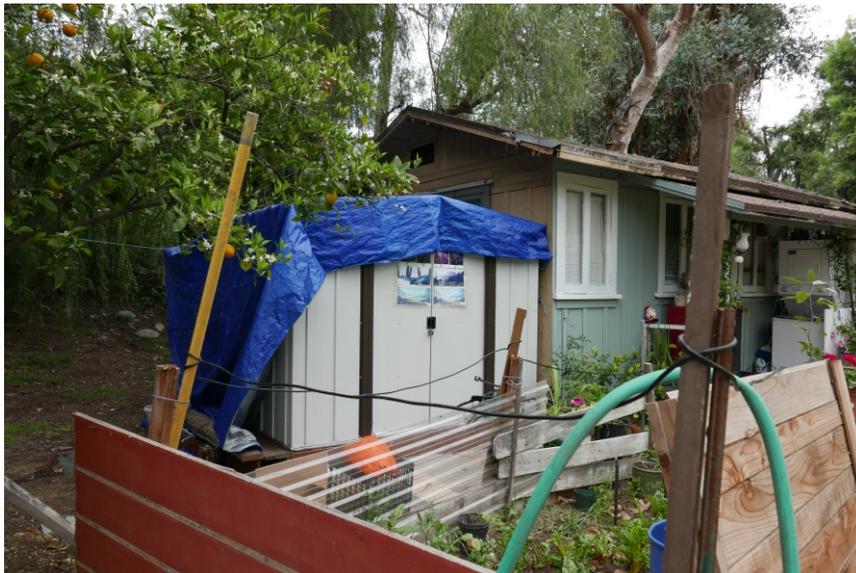
A prefabricated addition is located along the northern façade (Figure 23, *View of Northern Façade, Residence No. 3, 965 E. Grand View Avenue*). The residence has received numerous alterations, including altered windows, a new trellis, and new staircase.

Figure 23. View of Northern Façade, Residence No. 3, 965 E. Grand View Avenue
SOURCE: *Sapphos Environmental, Inc., 2018*

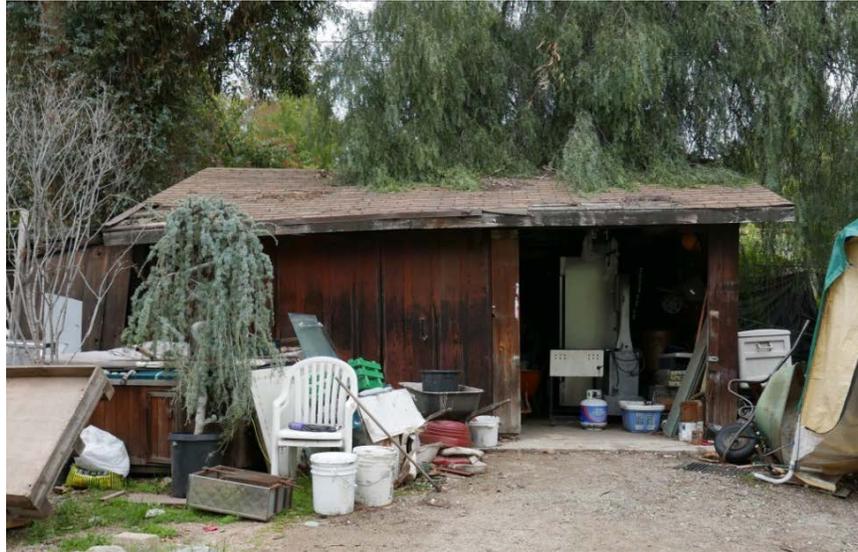
Shed No. 2 is located to the north of residence No. 3 and measures approximately 1,000 square feet. The shed was likely constructed in the 1900s–1910s, has board and batten siding, and a gable roof clad in shingles. Along its western façade, shed No. 2 has a large entrance likely used for vehicles and a concrete foundation (Figure 24, *View of Western Façade, Shed No. 2, 965 E. Grand View Avenue*).

Figure 24. View of Western Façade, Shed No. 2, 965 E. Grand View Avenue
SOURCE: *Sapphos Environmental, Inc., 2018*

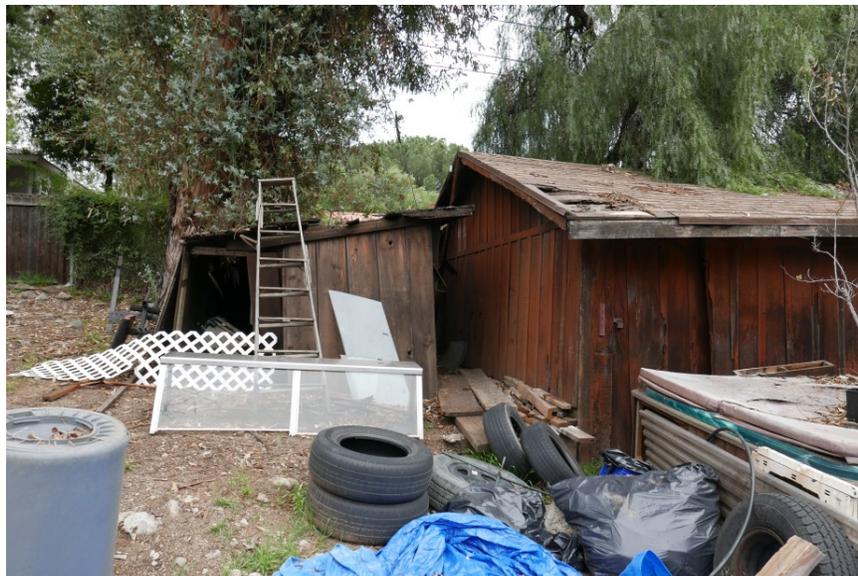
A smaller, lean-to shed is attached on the shed's northern façade. The shed is in poor condition and much of the wood has rotted over time due to neglect (Figure 25, *View of Northern Façade, Shed No. 2, 965 E. Grand View Avenue*).

Figure 25. View of Northern Façade, Shed No. 2, 965 E. Grand View Avenue
SOURCE: *Sapphos Environmental, Inc., 2018*

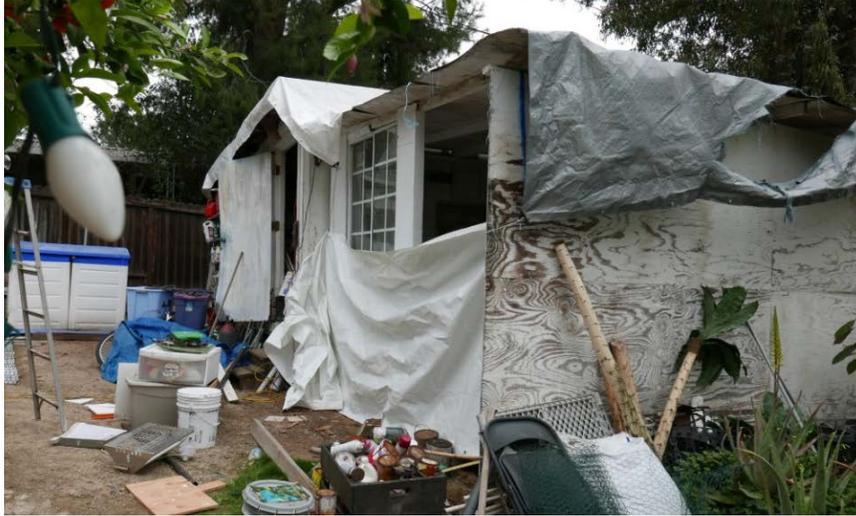
Just north of shed No. 2 is located shed No. 3. This shed measures approximately 500–1,000 square feet and was likely constructed piece-meal from the 1900s to the 1930s. The building is constructed of wood and features both plywood and board and batten siding. Along the northern façade are paired double-acting doors with multiple lights (Figure 26, *View of Northern Façade, Shed No. 3, 965 E. Grand View Avenue*).

Figure 26. View of Northern Façade, Shed No. 3, 965 E. Grand View Avenue
SOURCE: *Sapphos Environmental, Inc., 2018*

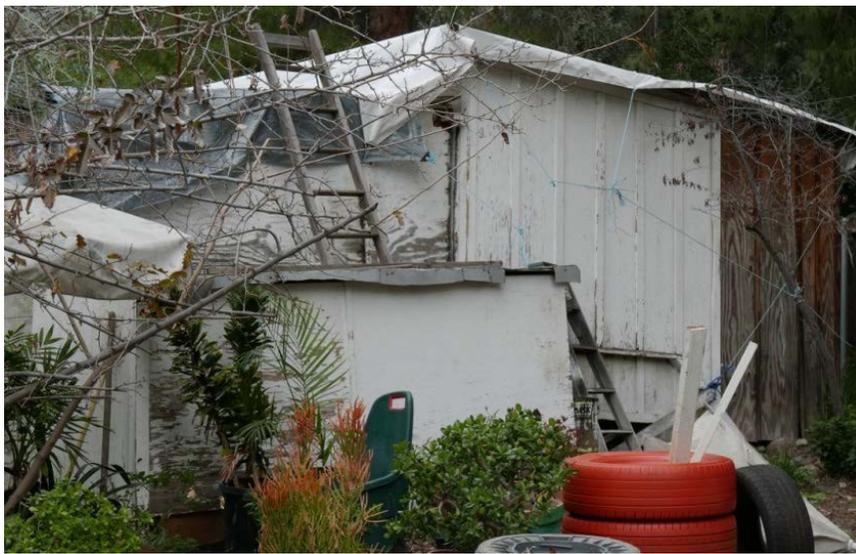
The southern façade evidences the various construction phases of this building: half of the building is clad in board and batten, and likely dates to the 1900–1910s, whereas another ell is much newer and constructed of plywood. The roof is a combination of flat and shed-style forms and is covered in a plastic tarp. The structure has received numerous alterations and is in poor condition due to neglect (Figure 27, *View of Southern Façade, Shed No. 3, 965 E. Grand View Avenue*)

Figure 27. View of Southern Façade, Shed No. 3, 965 E. Grand View Avenue
SOURCE: *Sapphos Environmental, Inc., 2018*

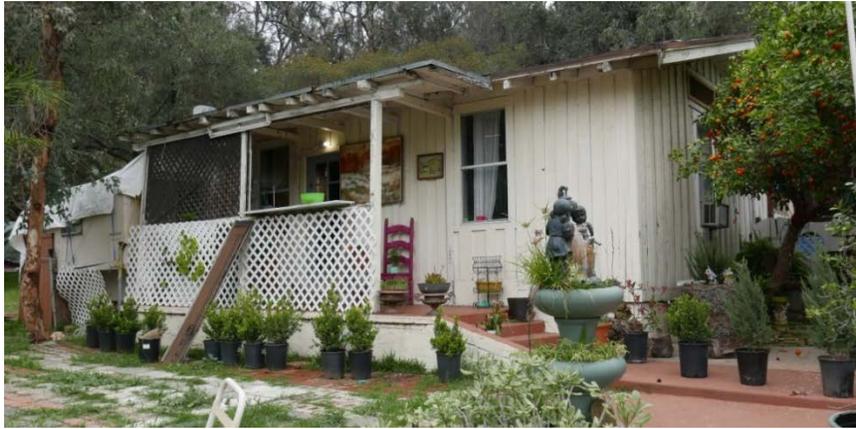
The northernmost building on the parcel is residence No. 4. This residence measures approximately 1,500 square feet, has a rectangle footprint, is vernacular, and was constructed at an unknown date, possibly between 1900 and 1920 based upon the style and materials of the building. The building's primary façade faces west and is accessible via an enclosed entrance and stairway (Figure 28, *General View of Residence No. 4 from Southwest, 965 E. Grand View Avenue*).

Figure 28. General View of Residence No. 4 from Southwest, 965 E. Grand View Avenue
SOURCE: *Sapphos Environmental, Inc., 2018*

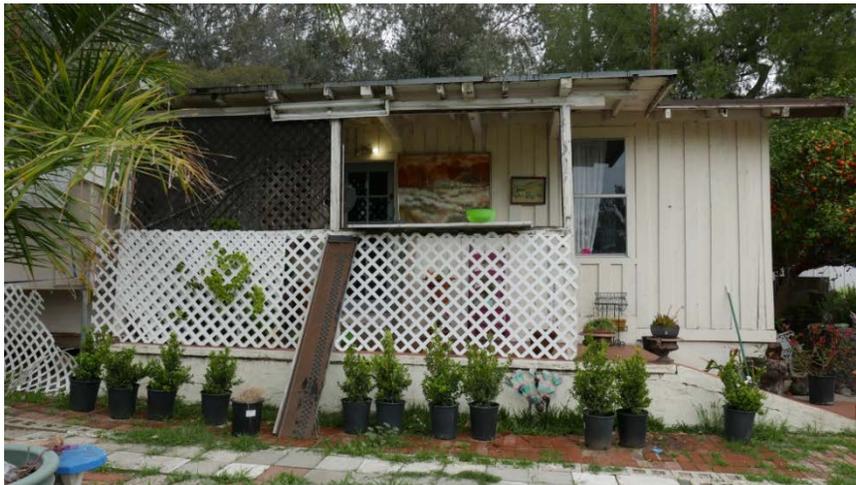
The building's exterior is clad in board and batten siding. Residence No. 4 has a broken gable roof with exposed rafter tails, one indicator of an early date of construction. The roof is clad in composition shingles, and appears to have been extended on the primary façade to shelter the entrance. This overhang is upheld by squared wood posts and enclosed with waist-high wood latticework sheets. This later addition also altered the way the building is entered with a raised porch and concrete stairway located parallel to the primary façade. Double-hung wood windows are located on the primary façade (Figure 29, *View of Primary [Western] Façade, Residence No. 4, 965 E. Grand View Avenue*).

Figure 29. View of Primary (Western) Façade, Residence No. 4, 965 E. Grand View Avenue
SOURCE: *Sapphos Environmental, Inc., 2018*

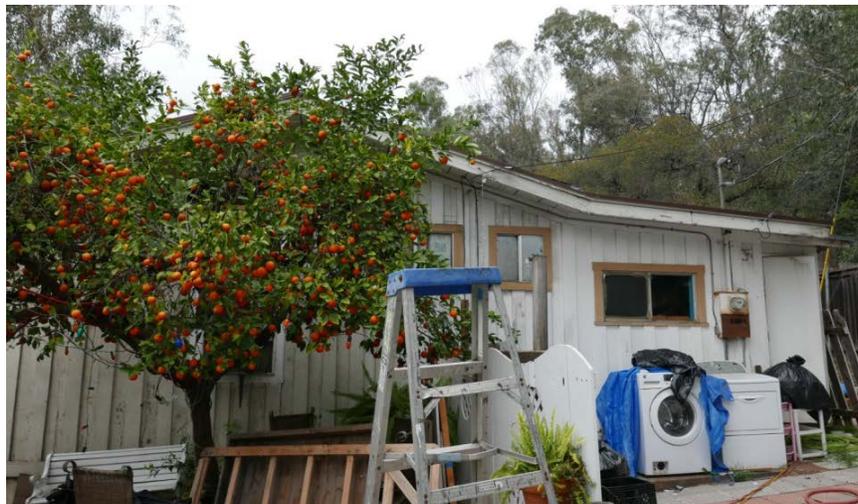
The southern façade of the property illustrates the broken gable roof, as well as the unoriginal sliding aluminum windows; these replaced what were likely wood windows at an unknown date. The eastern façade of the building features what is likely an alteration, as the rafter tails do not overhang as they do on the primary façade (Figure 30, *View of Southern Façade, Residence No. 4, 965 E. Grand View Avenue*).

Figure 30. View of Southern Façade, Residence No. 4, 965 E. Grand View Avenue
SOURCE: *Sapphos Environmental, Inc., 2018*

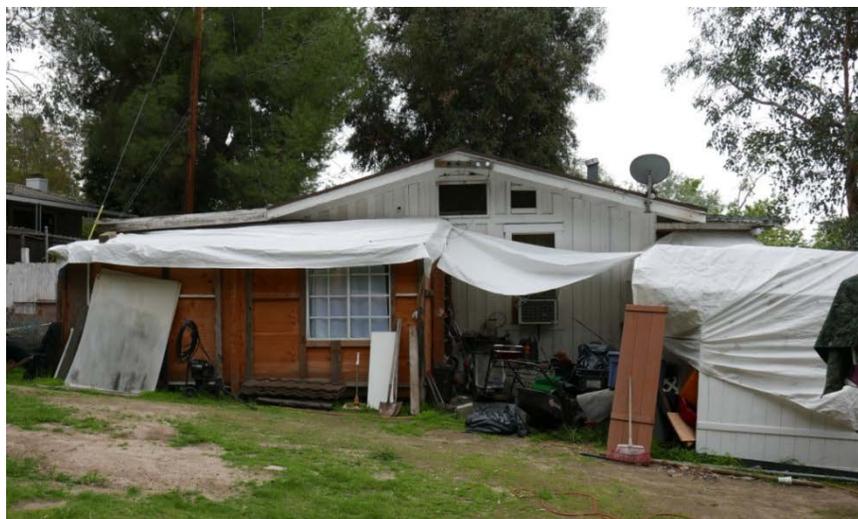
Figure 31. View of Northern Façade, Residence No. 4, 965 E. Grand View Avenue
SOURCE: *Sapphos Environmental, Inc., 2018*

The northern façade of residence No. 4 evidences a vent to provide passive air flow beneath the roof and a number of smaller, likely altered windows. An addition of wood with a shed roof is constructed off this façade and features vinyl 8-light windows. This addition was completed in 1983.¹¹ This residence has received numerous alterations and appears to suffer from deferred maintenance as is evident in the roof and siding (Figure 31, *View of Northern Façade, Residence No. 4, 965 E. Grand View Avenue*).

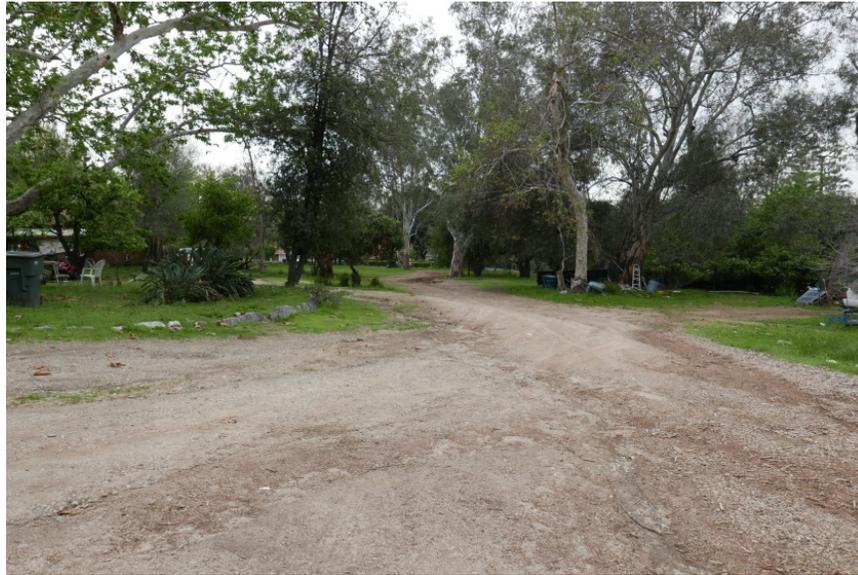
Figure 32. View of Driveway and Trees, 965 E. Grand View Avenue
SOURCE: *Sapphos Environmental, Inc., 2018*

The primary driveway winds along the central region of the parcel, skirting around various native trees (Figure 32, *View of Driveway and Trees, 965 E. Grand View Avenue*). The rear yard of the property is mostly undeveloped and encapsulates the woodlands that are native to the foothills (Figure 33, *View of Yard, 965 E. Grand View Avenue*).

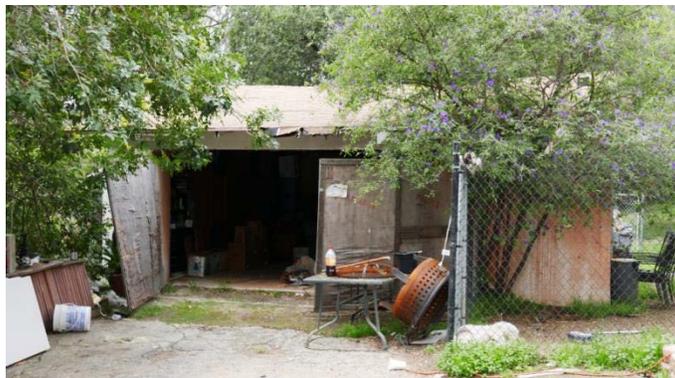
Shed No. 1 is located perpendicular and to the southwest of the residence and measures approximately 600 square feet. The shed is constructed of wood with a stucco exterior, has a shingle-clad gable roof, concrete floors, and wood doors. The roof eaves have sustained damage over time and the wood doors are only partially attached to the building.

View of Shed No. 1, 935 E. Grand View Avenue

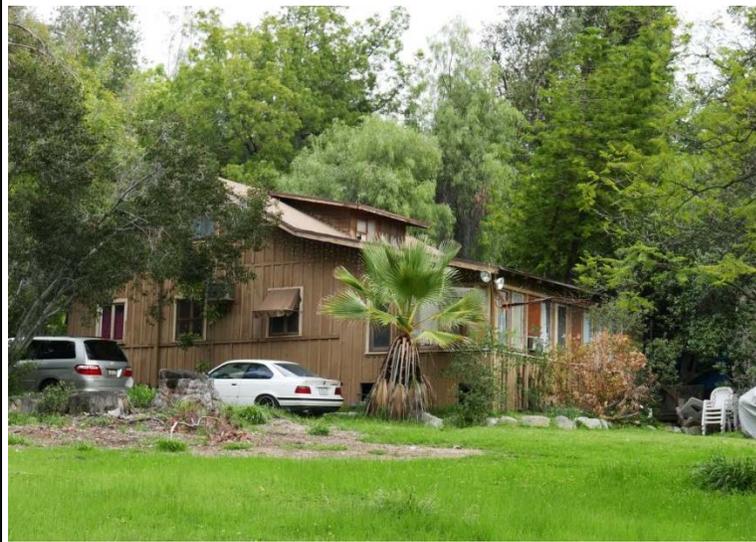
P5b. Description of Photo (view, date, accession #): Facing northeast; View of Residence No. 2, March 21, 2018; Photo No. L1150057 (See Continuation Sheet page 5)

The building has a rectangular footprint, broken gable roof, and central sleeping porch. It was likely originally constructed in the turn-of-the-century cabin style with some Craftsman-style alterations. However, the property no longer retains this appearance due to alterations. The primary (southern) façade of the residence features the central sleeping porch that was possibly an enclosure of an earlier porch; this alteration likely occurred in the 1910-1920s. An original dormer with a shed roof and wood shingle cladding is centered on the broken-gable roof. The exterior of the building was re-clad in board-and-batten siding at an unknown date; as visible from the dormer, the building was likely originally clad in wood shingles. Fenestration is composed of a ribbon of wood mullion casement windows that wraps around the three-sided sleeping porch and dormer.

Although the property may have originally had an exterior, exposed staircase, this staircase appears to be newer, likely dates to the 1960s, and appears to be an addition. The southeastern corner of the residence includes a roughly-constructed shelter that provides entrance to the sleeping porch. This shelter is built of wood posts with waist-high plywood walls and a flat, corrugated metal roof. It is a modern alteration to the building. Residence No. 2 has received numerous alterations over the past 100+ years and is in fairly poor condition due to neglect.

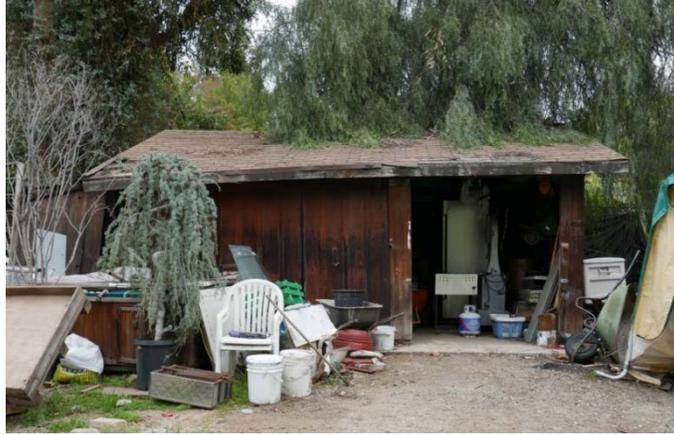
View of Shed No. 2, 965 E. Grand View Avenue

Shed No. 2 is located to the north of residence No. 3 and measures approximately 1,000 square feet. The shed was likely constructed in the 1900s-1910s, has board and batten siding, and a gable roof clad in shingles. Along its western façade, shed No. 2 has a large entrance likely used for vehicles and a concrete foundation. A smaller, lean-to shed is attached on the shed's northern façade. The shed is in poor condition and much of the wood has rotted over time due to neglect.
