FINAL REPORT

**UPDATE OF
PAVEMENT MANAGEMENT PROGRAM
(Citywide)**

2023-2026

City of Sierra Madre, CA

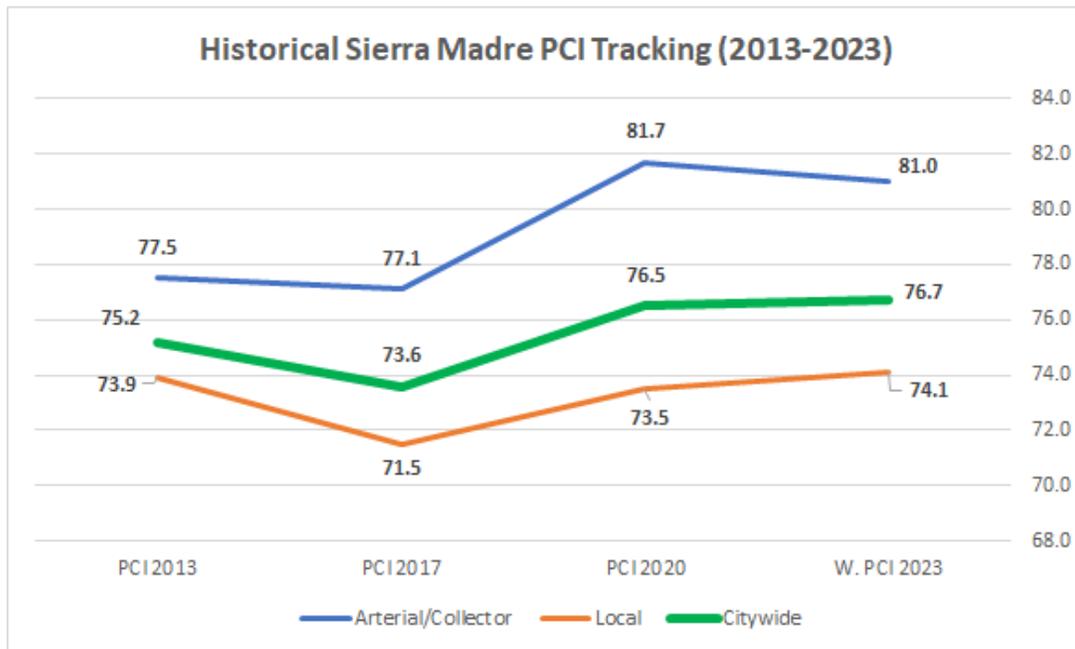
Figure 2 – Historical Sierra Madre Weighted PCI Tracking (2013-2023)

The overall condition of the City’s network is “Good” with a weighted average PCI of **76.7** based on the conditions and surface areas found within each segment. Based upon these findings, comparing the PCI conditions reported to the City in 2020, the City’s PCI rating has slightly increased from 76.5 to 76.7 (0.3% increase).

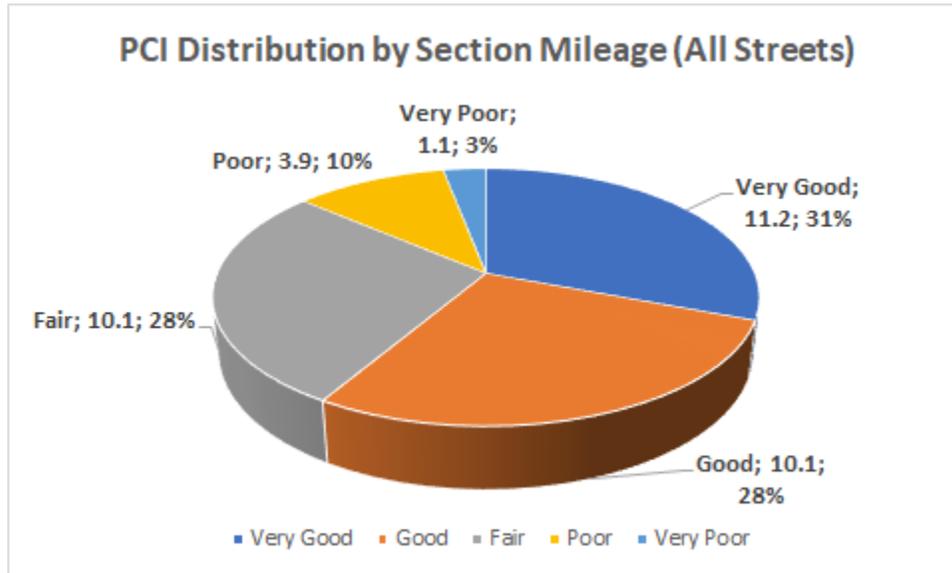
Figure 3 – PCI Condition Distribution by Miles for All Streets

As shown above, a large majority of segments are evenly distributed through Very Good to Good condition categories (59%). For a network in “preventive” condition status you would typically see Very Good and Good section percentage totals at the 60 to 70% range. These findings indicate that the proper rehabilitation maintenance needs have been well managed over the past 7+ years, however, with these positive findings it is key to point out that proper preventative maintenance needs to be funded as well as proactive rehabilitation projects.

Citywide, approximately 42% of the City’s pavement sections within a condition level of “Fair to Poor” (approximately 15.1 section miles), a proactive overlay rehabilitation program needs to be implemented and funded; this will increase the citywide weighted PCI to a higher level while reducing deferred maintenance costs in fiscal years 2023 and beyond. Approximately <1% of the network qualifies for reconstruction.

As shown in Figure 3, 59% of the City’s streets are in Very Good to Good condition. These sections will be targeted for “preventive” maintenance within our Capital Improvement Program (CIP) recommendations. The reasoning in doing this is to extend the life cycles of those “good” pavement sections which accrues capital saving to aggressively rehabilitate those pavement sections that are below the “minimal level of service”.

Furthermore, as large overlay projects are considered for funding, the City should also consider using sub-grade R - Values, structural design, distress severities and extents as parameters for determining whether a pavement section that lies within the Fair to Very Poor condition range should be overlaid or reconstructed. PCI conditions reflect “surface” conditions; additional sub-surface data such as coring data, R-Values and asphalt depths will provide City to with a better approach to the maintenance that should be applied.

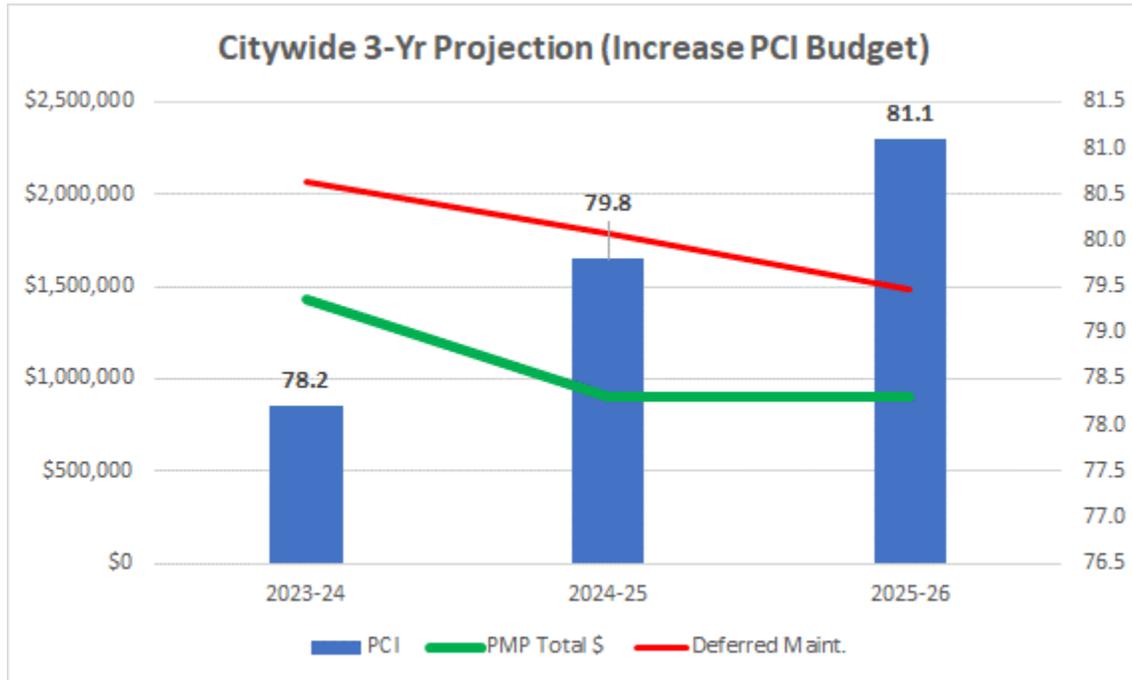
Figure 5 – Resulting Network PCI (Actual Budget)

The resulting “increase of the weighted PCI” shown above for the entire network demonstrates how applying ample/appropriate capital funds to specific areas of the network allows the City’s pavement conditions to appreciate at a rate that is conducive to a successful PMP. Additionally, even with the limited budget, the City should continue to implement localized maintenance (i.e. alternative High Density Mineral Bond (HDMB) applications, deep patching, leveling courses, crack sealing, etc.) prior to any major slurry seal and/or overlay maintenance. By performing stop gap measures to individual pavement sections the overall performance of the sections condition will improve over time and sustain itself longer than if no preventive maintenance was performed.

We recommend that a stronger focus be placed on the Local network improvements due to the fact that the network has a moderately lower weighted PCI than the Arterials (7 point variance). We still recommend consistent maintenance to the Arterial network (i.e. localized patching, cape seal, AC Overlay through the use of awarded Proposition C and Measure R funds) and this is shown within our reporting in Section IV. But again, with the Local network showing a higher degree of negative results, a new focus for rehabilitations and proactive overlays should be considered.

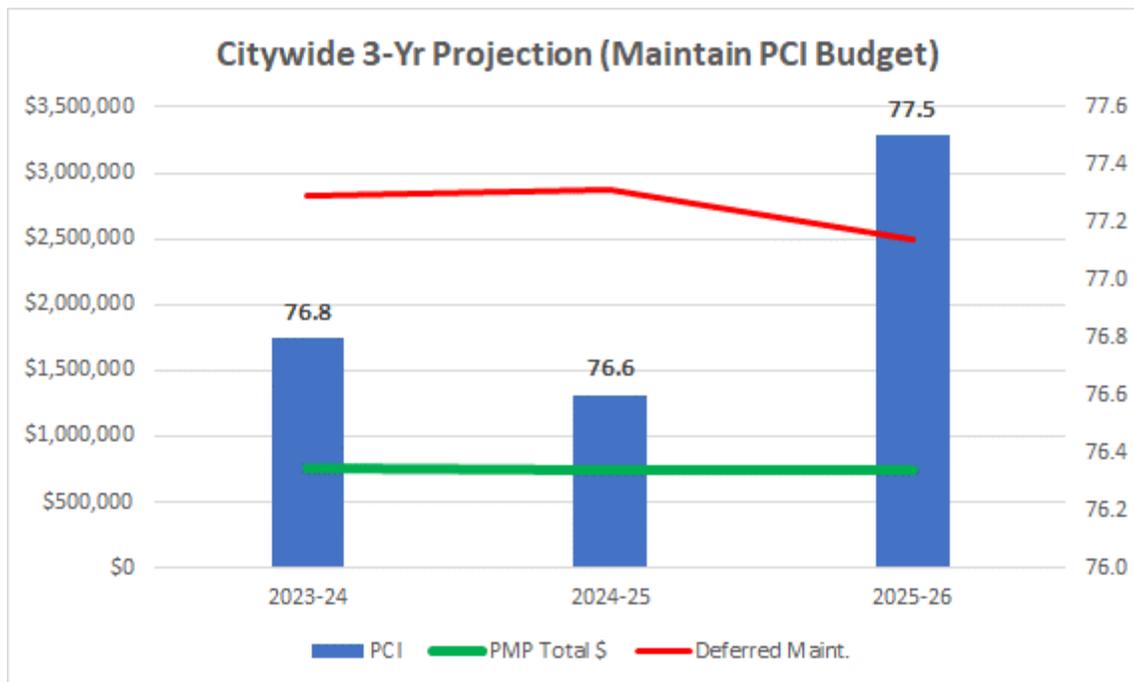
Figure 6 – Resulting Network PCI (Maintain Budget)

Referring to Table 8, it is noted that the weighted PCI maintains itself through the three-year projection (76.7 to 77.5). However, the annual deferred maintenance total only slightly decreases from \$2.8 million to \$2.5 million at the end of the three-years; moderately higher than the previous budget scenario. If the City utilizes an average annual budget of \$743,500/yr for slurry, overlay, and reconstruction maintenance as shown above, the City will be able to “hold” the current conditions and will continue to see an moderate amount of deferred maintenance by FY 2025-26 (mostly overlay maintenance).

Once the City has performed the recommended pavement rehabilitation projects for FY 2023 through 2024; the City should consider establishing a cape seal/slurry maintenance “neighborhood” strategy for several reasons. First, preventive maintenance applications applied five plus (5+) years after rehabilitation, like those mentioned above, will help to sustain high levels of condition while reducing annual expenditures. Secondly, with a citywide maintenance neighborhood methodology established, four beneficial impacts occur:
